Access Compliance Report

Public Rights-of-Way

(Curb Ramps)

Intersection ID: N/A		Main Street: ARROWOOD_RD		Cross Street: ROYAL_POINT_DR		Location: SW											
ADA ID: 380A1432A57C		Ramp Type: Directional1		Initial Pass/Fail: Fail		Overall Compliance: No		Severity Score: 25									
Codes/Mitigation Info/Possible Solution				Field Measurements/Component Compliance													
<div>

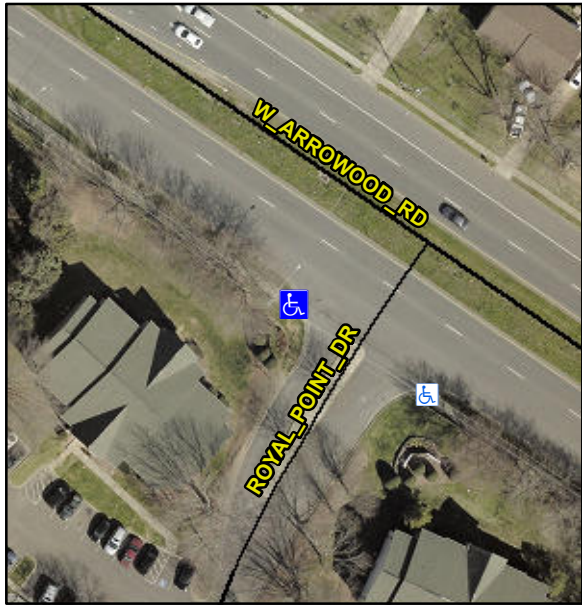
No		Ramp Slope (%)		8.7		N/A		Grade Break XSlope (%)		0.0			
				No		Ramp XSlope (%)		6.0									
				N/A		Flare Type LT		N/A		N/A		Flare Type RT		N/A			
				N/A		Flare Slope LT (%)		N/A		N/A		Flare Slope RT (%)		0.0			
				N/A		Flare Traversable LT?		N/A		N/A		Flare Traversable RT?		N/A			
				N/A		Landing Length (in)		0.0		N/A		DWS Provided?		N/A			
				N/A		Landing Width (in)		0.0		N/A		DWS Contrast?		N/A			
				N/A		Landing Slope (%)		0.0		N/A		DWS Length (in)		N/A			
				N/A		Landing X Slope (%)		0.0		N/A		DWS Full Width?		N/A			
				N/A		Landing Curb? (Y/N)		N/A		N/A		DWS Offset LT (in)		N/A			
				N/A		Shared Landing?		N/A		N/A		DWS Offset RT (in)		N/A			
				N/A		Gutter Ponding?		0.0		N/A		Gutter Slope (%)		N/A			
				N/A		Gutter Lip Ht (in)		0.0		N/A		Gutter X Slope (%)		N/A			
				N/A		Painted X Walk1?		No				Road Slope (%)		3.5			
						X Walk 1 Direction		To E				Road X Slope (%)		5.7

X Walk 1 Width (in)		N/A				Clear Space?		N/A			
						X Walk 1 Slope (%)		3.5		N/A		Clear Space to XWalk (in)		N/A			
						X Walk 1 X Slope (%)		5.7		N/A		Storm Grate/Utility Hazard?		N/A			
				N/A		Ramp inside XWalk1?		N/A				Storm Grate/Utility Type					
				N/A		Any Obstructions?		N/A						N/A			
						Obstruction Type				Yes		Surface Condition? (G/P)		Good			
										N/A		N/A		Curb Slope (%)		13.1

</div> <div>Possible Solutions:</div> <div>Remove & Replace Entire Ramp.</div> <div>Surveyor Notes:</div> <div>N/A</div> <div>PROW/ADA:</div> <div>R304.2.2, R304.5.3</div> <div>Street 1 Name</div> <div>ROYAL POINT DR</div> <div>Stop Condition-Street 1</div> <div>StopSign</div> <div>Street 2 Name</div> <div>N/A</div> <div>Stop Condition-Street 2</div> <div>N/A</div> <div>Total Cost:</div> <div>\$</div> <div>1600.00</div>				Compliance		Description		Data		Compliance		Description		Data			
				N/A		Ramp Length (in)		41.0		N/A		Grade Break?		N/A			
				Yes		Ramp Width (in)		60.0		N/A		Grade Break Slope (%)		0.0
