# Access Compliance Report

## Public Rights-of-Way

| Intersection ID: N/A | Main Street: DOGGETT_ST | Cross Street: N/A | Location: SW |
| ADA ID: 380C350A5E53 | Ramp Type: PerpDiag | Initial Pass/Fail: Fail | Overall Compliance: No |

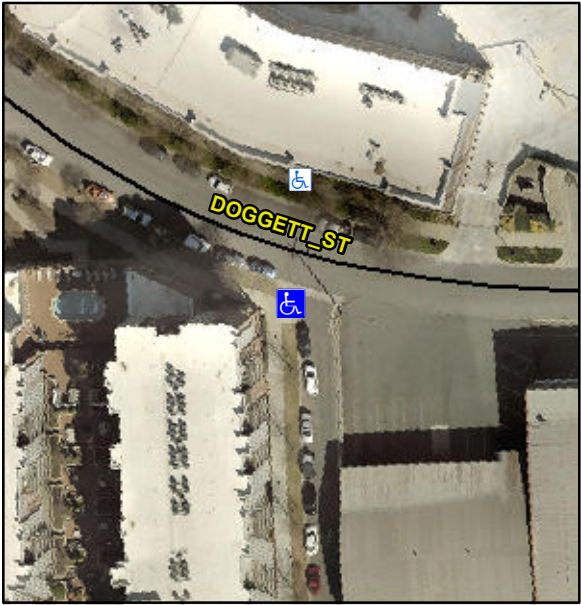
| | Remove & Replace Curb Ramp With Two New Directional Ramps or Equivalent. | N/A | Ramp Length (in) | 89.0 | No | Ramp Slope (%) | 9.6 |
| <p>Surveyor Notes:</p> <p>N/A</p> <p>PROW/ADA:</p> <p>R304.5.1, R304.2.2</p> | | No | Ramp Width (in) | 46.0 | Yes | Ramp XSlope (%) | 1.3 |
