Access Compliance Report

Public Rights-of-Way

(Curb Ramps)

Intersection ID: 4063	Main Street: MOUNTAIN_PINE_DR	Cross Street: SHADY_REACH_LN	Location: W
ADA ID: 3813FC99DC7A	Ramp Type: Perp	Initial Pass/Fail: Fail	Overall Compliance: No
Severity Score: 31.25			
Codes/Mitigation Info/Possible Solution		Field Measurements/Component Compliance

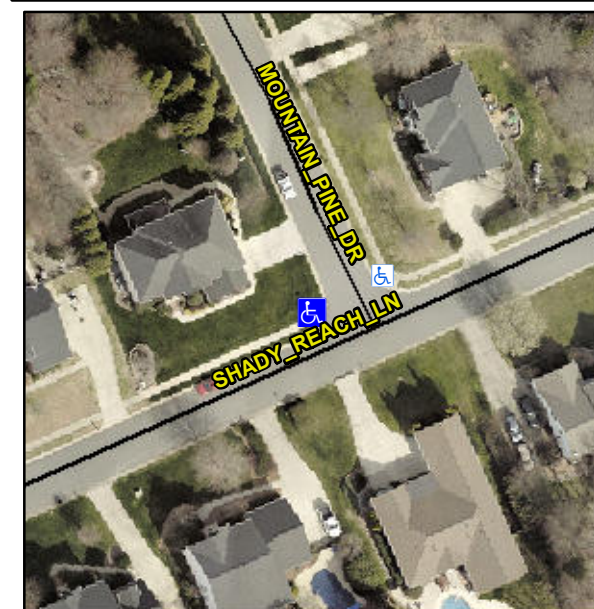
Not Found, R304.5.1, R304.2.2, R304.5.3

Compliance	Description	Data	Compliance	Description	Data
N/A	Ramp Length (in)	45.5	No	Ramp Slope (%)	8.4
No	Ramp Width (in)	33.5	No	Ramp XSlope (%)	4.2
N/A	Flare Type LT	N/A	N/A	Flare Type RT	N/A
N/A	Flare Slope LT (%)	N/A	N/A	Flare Slope RT (%)	N/A
N/A	Flare Traversable LT?	N/A	N/A	Flare Traversable RT?	N/A
N/A	Landing Length (in)	N/A	N/A	DWS Provided?	N/A
N/A	Landing Width (in)	N/A	N/A	DWS Contrast?	N/A
N/A	Landing Slope (%)	N/A	N/A	DWS Length (in)	N/A
N/A	Landing X Slope (%)	N/A	N/A	DWS Full Width?	N/A
N/A	Landing Curb? (Y/N)	N/A	N/A	DWS Offset (in)	N/A
N/A	Shared Landing?	N/A			
N/A	Gutter Ponding?	N/A	N/A	Gutter Slope (%)	N/A
N/A	Gutter Lip Ht (in)	N/A	N/A	Gutter X Slope (%)	N/A
N/A	Painted X Walk1?	No	N/A	Painted X Walk2?	N/A
	X Walk 1 Direction	To E		X Walk 2 Direction	N/A
N/A	X Walk 1 Width (in)	N/A	N/A	X Walk 2 Width (in)	N/A
	X Walk 1 Slope (%)	6.3		X Walk 2 Slope (%)	N/A
	X Walk 1 X Slope (%)	0.2		X Walk 2 X Slope (%)	N/A

Possible Solutions:

Remove & Replace Entire Ramp.

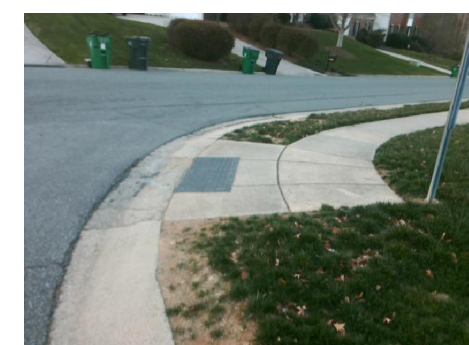
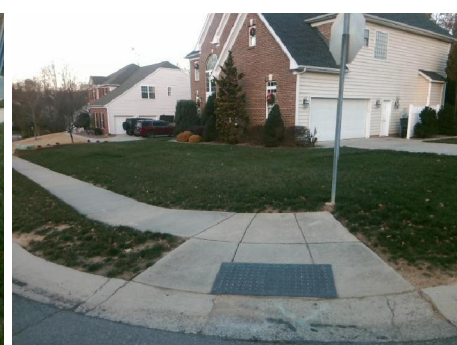
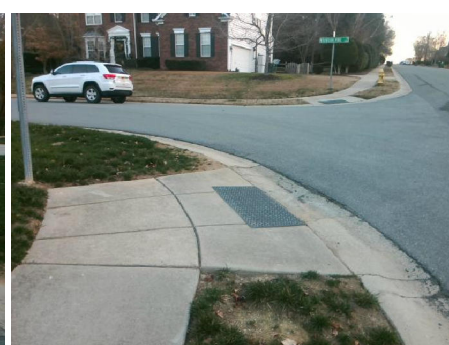
N/A	Ramp inside XWalk1?	N/A	N/A	Ramp inside XWalk2?	N/A
	Road Slope (%)	N/A	N/A	Clear Space?	N/A
	Road X Slope (%)	N/A	N/A	Clear Space to XWalk (in)	N/A
N/A	Any Obstructions?	N/A	N/A	Storm Grate/Utility Hazard?	N/A
	Obstruction Type			Storm Grate/Utility Type	
		N/A			N/A
			Yes	Surface Condition? (G/P)	Good
