Access Compliance Report

Public Rights-of-Way

(Curb Ramps)

Intersection ID: 3628	Main Street: DICKSON_LN	Cross Street: MAYCROFT_DR	Location:	N
ADA ID: 3822D52E7606	Ramp Type: Perp	Initial Pass/Fail: Fail	Overall Compliance: No	Severity Score: 1.25
Codes/Mitigation Info/Possible Solution		Field Measurements/Component Compliance

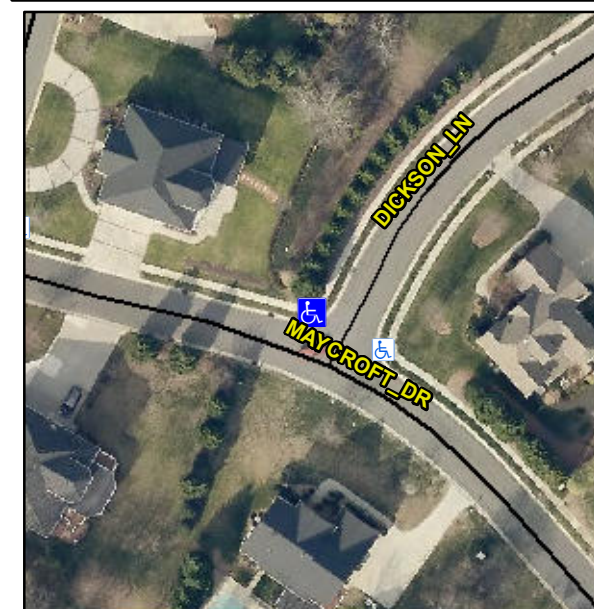
Not Found, R304.5.3

Compliance	Description	Data	Compliance	Description	Data
N/A	Ramp Length (in)	50.0	Yes	Ramp Slope (%)	5.1
Yes	Ramp Width (in)	102.0	No	Ramp XSlope (%)	2.6
N/A	Flare Type LT	N/A	N/A	Flare Type RT	N/A
N/A	Flare Slope LT (%)	N/A	N/A	Flare Slope RT (%)	N/A
N/A	Flare Traversable LT?	N/A	N/A	Flare Traversable RT?	N/A
N/A	Landing Length (in)	N/A	N/A	DWS Provided?	N/A
N/A	Landing Width (in)	N/A	N/A	DWS Contrast?	N/A
N/A	Landing Slope (%)	N/A	N/A	DWS Length (in)	N/A
N/A	Landing X Slope (%)	N/A	N/A	DWS Full Width?	N/A
N/A	Landing Curb? (Y/N)	N/A	N/A	DWS Offset (in)	N/A
N/A	Shared Landing?	N/A			
N/A	Gutter Ponding?	N/A	N/A	Gutter Slope (%)	N/A
N/A	Gutter Lip Ht (in)	1.0	N/A	Gutter X Slope (%)	N/A
N/A	Painted X Walk1?	No	N/A	Painted X Walk2?	N/A
	X Walk 1 Direction	To SE		X Walk 2 Direction	N/A
N/A	X Walk 1 Width (in)	N/A	N/A	X Walk 2 Width (in)	N/A
	X Walk 1 Slope (%)	8.0		X Walk 2 Slope (%)	N/A
	X Walk 1 X Slope (%)	0.2		X Walk 2 X Slope (%)	N/A

N/A	Ramp inside XWalk1?	N/A	N/A	Ramp inside XWalk2?	N/A
	Road Slope (%)	N/A	N/A	Clear Space?	N/A
	Road X Slope (%)	N/A	N/A	Clear Space to XWalk (in)	N/A
N/A	Any Obstructions?	N/A	N/A	Storm Grate/Utility Hazard?	N/A
	Obstruction Type			Storm Grate/Utility Type	
		N/A			N/A
			Yes	Surface Condition? (G/P)	Good

Remove & Replace Entire Ramp.

Total Cost: \$ 1850.00
