Access Compliance Report Public Rights-of-Way (Curb Ramps)

Intersection ID: 7042 Main Street: BACK_CREEK_DR Cross Street: E_W_T_HARRIS_BV Location: SW

ADA ID: 383189698352 Ramp Type: Perp Initial Pass/Fail: Fail Overall Compliance: No Severity Score: 12.5

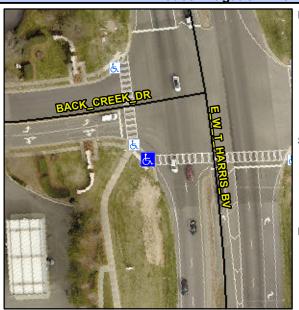
Comp	Compliance Description Data Compliance Description		liance Description	Data	
N/A	Ramp Length (in)	46.0	Yes	Ramp Slope (%)	7.4
Yes	Ramp Width (in)	48.0	No	Ramp XSlope (%)	6.2
N/A	Flare Type LT	N/A	N/A	Flare Type RT	N/A
N/A	Flare Slope LT (%)	N/A	N/A	Flare Slope RT (%)	N/A
N/A	Flare Traversable LT?	N/A	N/A	Flare Traversable RT?	N/A
N/A	Landing Length (in)	N/A	N/A	DWS Provided?	N/A
N/A	Landing Width (in)	N/A	N/A	DWS Contrast?	N/A
N/A	Landing Slope (%)	N/A	N/A	DWS Length (in)	N/A
N/A	Landing X Slope (%)	N/A	N/A	DWS Full Width?	N/A
N/A	Landing Curb? (Y/N)	N/A	N/A	DWS Offset (in)	N/A
N/A	Shared Landing?	N/A			
N/A	Gutter Ponding?	N/A	N/A	Gutter Slope (%)	N/A
N/A	Gutter Lip Ht (in)	N/A	N/A	Gutter X Slope (%)	N/A
N/A	Painted X Walk1?	Yes	N/A	Painted X Walk2?	N/A
	X Walk 1 Direction	То Е		X Walk 2 Direction	N/A
N/A	X Walk 1 Width (in)	110.0	N/A	X Walk 2 Width (in)	N/A
	X Walk 1 Slope (%)	9.7		X Walk 2 Slope (%)	N/A

X Walk 1 X Slope (%)	0.9		X Walk 2 X Slope (%)	N/A
N/A	Ramp inside XWalk1?	Yes	N/A	Ramp inside XWalk2?	N/A
	Road Slope (%)	N/A	N/A	Clear Space?	N/A
	Road X Slope (%)	N/A	N/A	Clear Space to XWalk (in)	N/A
N/A	Any Obstructions?	N/A	N/A	Storm Grate/Utility Hazard?	N/A
	Obstruction Type		l	Storm Grate/Utility Type	
		N/A			N/A
			Yes	Surface Condition? (G/P)	Good

Possible Solutions:					
Remove & Replace Entire Ramp.					
·					
Surveyor Notes:					
N/A					
PROW/ADA:					
R304.5.3
