Access Compliance Report

Public Rights-of-Way

(Curb Ramps)

Intersection ID: 52112	Main Street: YOUNGBLOOD_ST	Cross Street: POINDEXTER_DR	Location:	W
ADA ID: 383CAADAF09D	Ramp Type: Directional1	Initial Pass/Fail: Fail	Overall Compliance: No	Severity Score: 25
Codes/Mitigation Info/Possible Solution		Field Measurements/Component Compliance

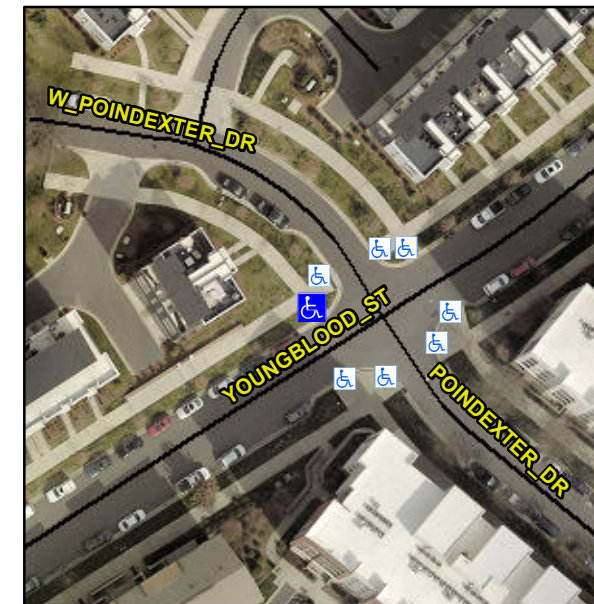
R304.2.2, R304.5.3

Compliance	Description	Data	Compliance	Description	Data
N/A	Ramp Length (in)	71.0	N/A	Grade Break?	N/A
Yes	Ramp Width (in)	96.0	N/A	Grade Break Slope (%)	0.0
No	Ramp Slope (%)	9.7	N/A	Grade Break XSlope (%)	0.0
No	Ramp XSlope (%)	5.4			
N/A	Flare Type LT	N/A	N/A	Flare Type RT	N/A
N/A	Flare Slope LT (%)	N/A	N/A	Flare Slope RT (%)	0.0
N/A	Flare Traversable LT?	N/A	N/A	Flare Traversable RT?	N/A
N/A	Landing Length (in)	0.0	N/A	DWS Provided?	N/A
N/A	Landing Width (in)	0.0	N/A	DWS Contrast?	N/A
N/A	Landing Slope (%)	0.0	N/A	DWS Length (in)	N/A
N/A	Landing X Slope (%)	0.0	N/A	DWS Full Width?	N/A
N/A	Landing Curb? (Y/N)	N/A	N/A	DWS Offset LT (in)	N/A
N/A	Shared Landing?	N/A	N/A	DWS Offset RT (in)	N/A
N/A	Gutter Ponding?	0.0	N/A	Gutter Slope (%)	N/A
N/A	Gutter Lip Ht (in)	0.0	N/A	Gutter X Slope (%)	N/A
N/A	Painted X Walk1?	No		Road Slope (%)	3.1
	X Walk 1 Direction	To SE		Road X Slope (%)	2.4
	X Walk 1 Width (in)	N/A		Clear Space?	N/A

X Walk 1 Slope (%)	3.1	N/A	Clear Space to XWalk (in)	N/A
	X Walk 1 X Slope (%)	2.4	N/A	Storm Grate/Utility Hazard?	N/A
N/A	Ramp inside XWalk1?	N/A		Storm Grate/Utility Type	
N/A	Any Obstructions?	N/A			N/A
	Obstruction Type		Yes	Surface Condition? (G/P)	Good
			N/A	Curb Slope (%)	9.4

Possible Solutions:

Remove & Replace Entire Ramp.
