Access Compliance Report

Public Rights-of-Way

(Curb Ramps)

Intersection ID: 29245	Main Street: CAYMUS_DR	Cross Street: MALLARD_FOREST_DR	Location: SE
ADA ID: 383FB324047F	Ramp Type: PerpDiag	Initial Pass/Fail: Fail	Overall Compliance: No
		Severity Score: 12.5

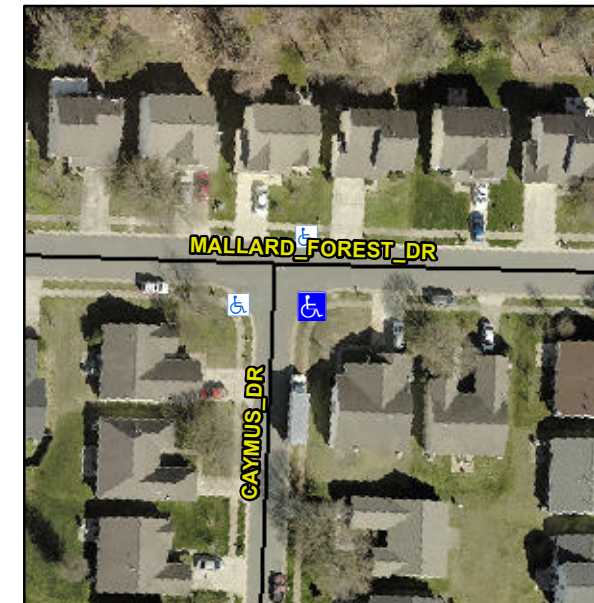
Not Found, R304.5.3

Compliance	Description	Data	Compliance	Description	Data
N/A	Ramp Length (in)	48.0	Yes	Ramp Slope (%)	5.1
Yes	Ramp Width (in)	49.0	No	Ramp XSlope (%)	6.4
N/A	Flare Type LT	N/A	N/A	Flare Type RT	N/A
N/A	Flare Slope LT (%)	N/A	N/A	Flare Slope RT (%)	N/A
N/A	Flare Traversable LT?	N/A	N/A	Flare Traversable RT?	N/A
N/A	Landing Length (in)	N/A	N/A	DWS Provided?	N/A
N/A	Landing Width (in)	N/A	N/A	DWS Contrast?	N/A
N/A	Landing Slope (%)	N/A	N/A	DWS Length (in)	N/A
N/A	Landing X Slope (%)	N/A	N/A	DWS Full Width?	N/A
N/A	Landing Curb? (Y/N)	N/A	N/A	DWS Offset (in)	N/A
N/A	Shared Landing?	N/A			
N/A	Gutter Ponding?	N/A	N/A	Gutter Slope (%)	N/A
N/A	Gutter Lip Ht (in)	N/A	N/A	Gutter X Slope (%)	N/A
N/A	Painted X Walk1?	No	N/A	Painted X Walk2?	No
	X Walk 1 Direction	To N		X Walk 2 Direction	To W
N/A	X Walk 1 Width (in)	N/A	N/A	X Walk 2 Width (in)	N/A
	X Walk 1 Slope (%)	1.3		X Walk 2 Slope (%)	1.6
	X Walk 1 X Slope (%)	2.0		X Walk 2 X Slope (%)	2.9

N/A	Ramp inside XWalk1?	N/A	N/A	Ramp inside XWalk2?	N/A
	Road Slope (%)	4.0	N/A	Clear Space?	N/A
	Road X Slope (%)	5.1	N/A	Clear Space to XWalk (in)	N/A
N/A	Any Obstructions?	N/A	N/A	Storm Grate/Utility Hazard?	N/A
	Obstruction Type			Storm Grate/Utility Type	
		N/A			N/A
		Yes		Surface Condition? (G/P)	Good

Remove & Replace Curb Ramp With Two New Directional Ramps or Equivalent.
