Access Compliance Report

Public Rights-of-Way

(Curb Ramps)

Intersection ID: 8616	Main Street: BEATTIES_FORD_RD	Cross Street: ST_MARK_ST	Location: NE
ADA ID: 3847B0701EC5	Ramp Type: BlendTrans1	Initial Pass/Fail: Fail	Overall Compliance: No
Severity Score: 21.25			
Codes/Mitigation Info/Possible Solution		Field Measurements/Component Compliance

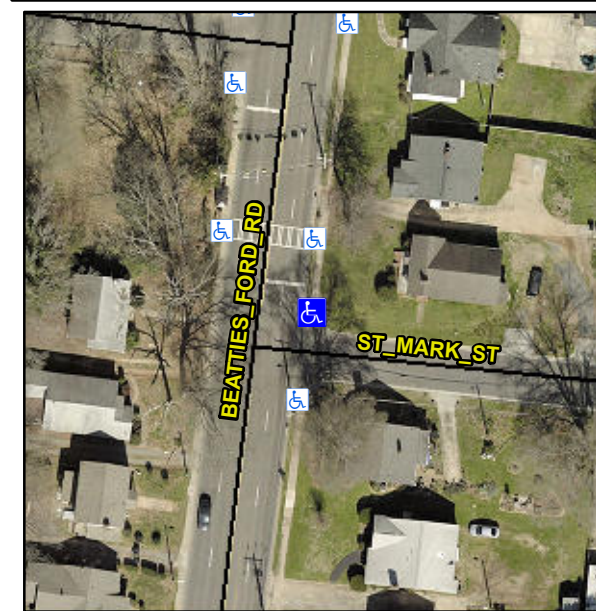
NO RT SW

Not Found, R304.5.1, R304.5.3

Compliance	Description	Data	Compliance	Description	Data
N/A	Ramp Length (in)	71.0	Yes	BlendTrans Slope (%)	2.3
No	Ramp Width (in)	47.5	No	BlendTrans XSlope (%)	5.3
N/A	Flare Type LT	N/A	N/A	Flare Type RT	N/A
N/A	Flare Slope LT (%)	N/A	N/A	Flare Slope RT (%)	N/A
N/A	Flare Traversable LT?	N/A	N/A	Flare Traversable RT?	N/A
N/A	Landing Length (in)	N/A	N/A	DWS Provided?	N/A
N/A	Landing Width (in)	N/A	N/A	DWS Contrast?	N/A
N/A	Landing Slope (%)	N/A	N/A	DWS Length (in)	N/A
N/A	Landing X Slope (%)	N/A	N/A	DWS Full Width?	N/A
N/A	Landing Curb? (Y/N)	N/A	N/A	DWS Offset (in)	N/A
N/A	Shared Landing?	N/A			
N/A	Gutter Ponding?	N/A	N/A	Gutter Slope (%)	N/A
N/A	Gutter Lip Ht (in)	N/A	N/A	Gutter X Slope (%)	N/A
N/A	Painted X Walk1?	No	N/A	Painted X Walk2?	N/A
	X Walk 1 Direction	To S		X Walk 2 Direction	N/A
	X Walk 1 Width (in)	N/A		X Walk 2 Width (in)	N/A
	X Walk 1 Slope (%)	1.2		X Walk 2 Slope (%)	N/A
	X Walk 1 X Slope (%)	8.7		X Walk 2 X Slope (%)	N/A

N/A	Ramp inside XWalk1?	N/A	N/A	Ramp inside XWalk2?	N/A
	Road Slope (%)	8.7		Clear Space?	N/A
	Road X Slope (%)	1.2	N/A	Clear Space to XWalk (in)	N/A
N/A	Any Obstructions?	N/A	N/A	Storm Grate/Utility Hazard?	N/A
	Obstruction Type			Storm Grate/Utility Type	
		N/A			N/A
			Yes	Surface Condition? (G/P)	Good
			No	Curb Slope (%)	17.7

Possible Solutions:

Remove & Replace Curb Ramp With Two New Directional Ramps or Equivalent.
