Access Compliance Report

Public Rights-of-Way

(Curb Ramps)

Intersection ID: 8735	Main Street: GLENWOOD_DR	Cross Street: ROWAN_ST	Location: SW
ADA ID: 384A64249194	Ramp Type: Perp	Initial Pass/Fail: Fail	Overall Compliance: No
Severity Score: 72.5			
Codes/Mitigation Info/Possible Solution		Field Measurements/Component Compliance

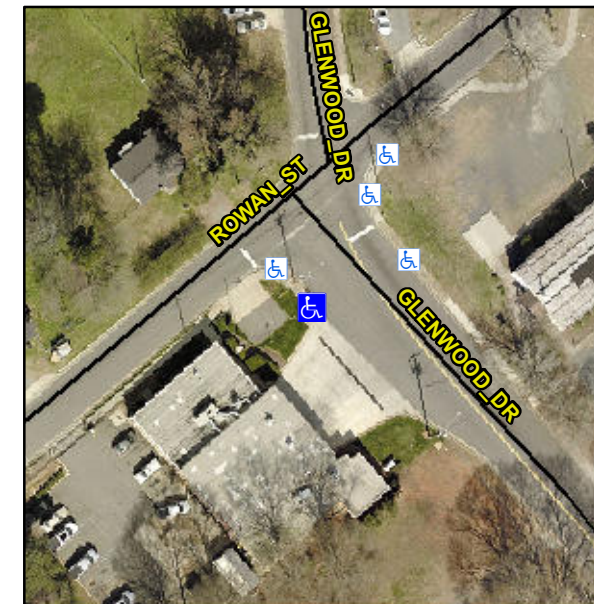
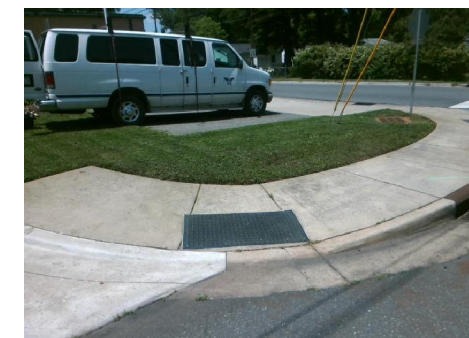
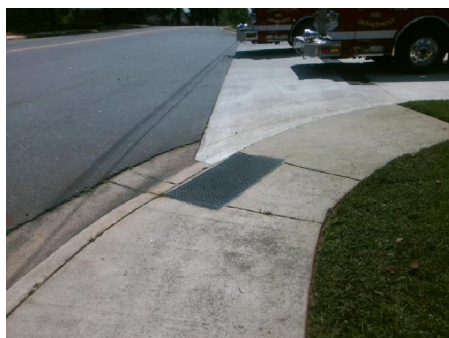
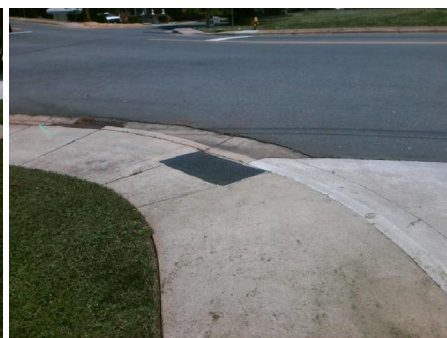
Not Found, R304.5.1, R304.2.2, R304.5.3

Compliance	Description	Data	Compliance	Description	Data
N/A	Ramp Length (in)	58.0	No	Ramp Slope (%)	8.9
No	Ramp Width (in)	30.0	No	Ramp XSlope (%)	7.2
N/A	Flare Type LT	N/A	N/A	Flare Type RT	N/A
N/A	Flare Slope LT (%)	N/A	N/A	Flare Slope RT (%)	N/A
N/A	Flare Traversable LT?	N/A	N/A	Flare Traversable RT?	N/A
N/A	Landing Length (in)	N/A	N/A	DWS Provided?	N/A
N/A	Landing Width (in)	N/A	N/A	DWS Contrast?	N/A
N/A	Landing Slope (%)	N/A	N/A	DWS Length (in)	N/A
N/A	Landing X Slope (%)	N/A	N/A	DWS Full Width?	N/A
N/A	Landing Curb? (Y/N)	N/A	N/A	DWS Offset (in)	N/A
N/A	Shared Landing?	N/A			
N/A	Gutter Ponding?	N/A	N/A	Gutter Slope (%)	N/A
N/A	Gutter Lip Ht (in)	N/A	N/A	Gutter X Slope (%)	N/A
N/A	Painted X Walk1?	No	N/A	Painted X Walk2?	N/A
	X Walk 1 Direction	To NE		X Walk 2 Direction	N/A
N/A	X Walk 1 Width (in)	N/A	N/A	X Walk 2 Width (in)	N/A
	X Walk 1 Slope (%)	4.3		X Walk 2 Slope (%)	N/A
	X Walk 1 X Slope (%)	4.5		X Walk 2 X Slope (%)	N/A

N/A	Ramp inside XWalk1?	N/A	N/A	Ramp inside XWalk2?	N/A
	Road Slope (%)	N/A	N/A	Clear Space?	N/A
	Road X Slope (%)	N/A	N/A	Clear Space to XWalk (in)	N/A
N/A	Any Obstructions?	N/A	N/A	Storm Grate/Utility Hazard?	N/A
	Obstruction Type			Storm Grate/Utility Type	
		N/A			N/A
			Yes	Surface Condition? (G/P)	Good

Possible Solutions:

Remove & Replace Entire Ramp.
