Access Compliance Report

Public Rights-of-Way

(Curb Ramps)

Intersection ID: 30073	Main Street: SUNSET_RD	Cross Street: SUNSET_VILLAGE_DR	Location: NW
ADA ID: 384F175EB223	Ramp Type: Perp	Initial Pass/Fail: Fail	Overall Compliance: No
Severity Score: 8.75			
Codes/Mitigation Info/Possible Solution		Field Measurements/Component Compliance

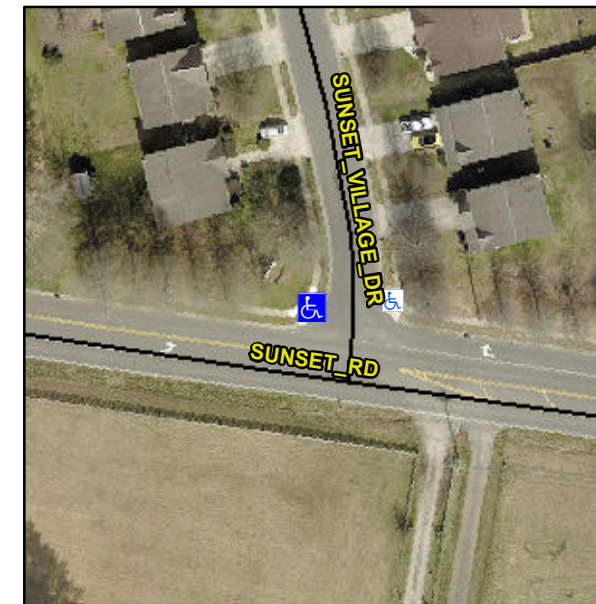
PROW/ADA:

Not Found, R304.5.1

Compliance	Description	Data	Compliance	Description	Data
N/A	Ramp Length (in)	27.0	Yes	Ramp Slope (%)	7.0
No	Ramp Width (in)	45.0	Yes	Ramp XSlope (%)	1.4
N/A	Flare Type LT	N/A	N/A	Flare Type RT	N/A
N/A	Flare Slope LT (%)	N/A	N/A	Flare Slope RT (%)	N/A
N/A	Flare Traversable LT?	N/A	N/A	Flare Traversable RT?	N/A
N/A	Landing Length (in)	N/A	N/A	DWS Provided?	N/A
N/A	Landing Width (in)	N/A	N/A	DWS Contrast?	N/A
N/A	Landing Slope (%)	N/A	N/A	DWS Length (in)	N/A
N/A	Landing X Slope (%)	N/A	N/A	DWS Full Width?	N/A
N/A	Landing Curb? (Y/N)	N/A	N/A	DWS Offset (in)	N/A
N/A	Shared Landing?	N/A			
N/A	Gutter Ponding?	N/A	N/A	Gutter Slope (%)	N/A
N/A	Gutter Lip Ht (in)	N/A	N/A	Gutter X Slope (%)	N/A
N/A	Painted X Walk1?	No	N/A	Painted X Walk2?	N/A
	X Walk 1 Direction	To E		X Walk 2 Direction	N/A
N/A	X Walk 1 Width (in)	N/A	N/A	X Walk 2 Width (in)	N/A
	X Walk 1 Slope (%)	3.4		X Walk 2 Slope (%)	N/A
	X Walk 1 X Slope (%)	2.6		X Walk 2 X Slope (%)	N/A

N/A	Ramp inside XWalk1?	N/A	N/A	Ramp inside XWalk2?	N/A
	Road Slope (%)	N/A	N/A	Clear Space?	N/A
	Road X Slope (%)	N/A	N/A	Clear Space to XWalk (in)	N/A
N/A	Any Obstructions?	N/A	N/A	Storm Grate/Utility Hazard?	N/A
	Obstruction Type			Storm Grate/Utility Type	
		N/A			N/A
		Yes		Surface Condition? (G/P)	Good

Possible Solutions:

Remove & Replace Entire Ramp.
