Access Compliance Report

Public Rights-of-Way

(Curb Ramps)

Intersection ID: 14189	Main Street: E_KINGSTON_AV	Cross Street: EUCLID_AV	Location:	N
ADA ID: 385D3B0B46F2	Ramp Type: Perp	Initial Pass/Fail: Fail	Overall Compliance: No	Severity Score: 1.25

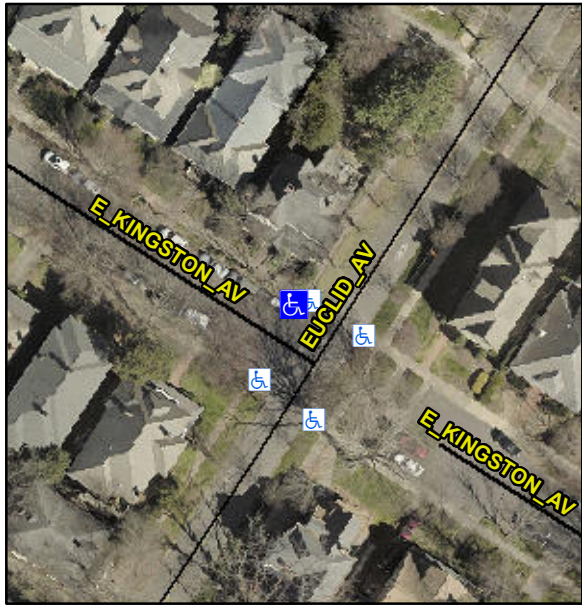
Possible Solutions:		Compliance	Description	Data	Compliance	Description	Data
	Remove & Replace Entire Ramp.		N/A	Ramp Length (in)	48.0	Yes	Ramp Slope (%)	6.8
			Yes	Ramp Width (in)	60.0	No	Ramp XSlope (%)	2.5
			N/A	Flare Type LT	N/A	N/A	Flare Type RT	N/A
			N/A	Flare Slope LT (%)	N/A	N/A	Flare Slope RT (%)	N/A
			N/A	Flare Traversable LT?	N/A	N/A	Flare Traversable RT?	N/A
			N/A	Landing Length (in)	N/A	N/A	DWS Provided?	N/A
			N/A	Landing Width (in)	N/A	N/A	DWS Contrast?	N/A
			N/A	Landing Slope (%)	N/A	N/A	DWS Length (in)	N/A
			N/A	Landing X Slope (%)	N/A	N/A	DWS Full Width?	N/A
Surveyor Notes:			N/A	Landing Curb? (Y/N)	N/A	N/A	DWS Offset (in)	N/A
PROW/ADA:			N/A	Shared Landing?	N/A			
R304.5.3			N/A	Gutter Ponding?	N/A	N/A	Gutter Slope (%)	N/A
			N/A	Gutter Lip Ht (in)	N/A	N/A	Gutter X Slope (%)	N/A
			N/A	Painted X Walk1?	No	N/A	Painted X Walk2?	N/A

X Walk 1 Direction	To SW		X Walk 2 Direction	N/A
			N/A	X Walk 1 Width (in)	N/A	N/A	X Walk 2 Width (in)	N/A
				X Walk 1 Slope (%)	4.1		X Walk 2 Slope (%)	N/A
				X Walk 1 X Slope (%)	1.6		X Walk 2 X Slope (%)	N/A
			N/A	Ramp inside XWalk1?	N/A	N/A	Ramp inside XWalk2?	N/A
				Road Slope (%)	N/A	N/A	Clear Space?	N/A
				Road X Slope (%)	N/A	N/A	Clear Space to XWalk (in)	N/A
			N/A	Any Obstructions?	N/A	N/A	Storm Grate/Utility Hazard?	N/A
				Obstruction Type			Storm Grate/Utility Type	
						N/A		N/A
						Yes	Surface Condition? (G/P)	Good
