Access Compliance Report Public Rights-of-Way (Curb Ramps)

Intersection ID: 12958 Main Street: E 3RD ST **Cross Street: S DAVIDSON ST** Location: W ADA ID: 386101FB760F Ramp Type: PerpDiag Initial Pass/Fail: Fail **Overall Compliance: No Severity Score:** 10

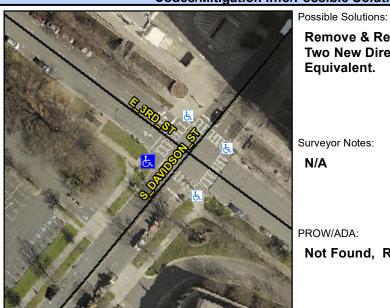
Field Measurements/Component Compliance						
	Compliance Description		Data	Comp	liance Description	Data
	N/A	Ramp Length (in)	118.0	Yes	Ramp Slope (%)	6.0
	No	Ramp Width (in)	36.0	No	Ramp XSlope (%)	2.3
	N/A	Flare Type LT	N/A	N/A	Flare Type RT	N/A
	N/A	Flare Slope LT (%)	N/A	N/A	Flare Slope RT (%)	N/A
	N/A	Flare Traversable LT?	N/A	N/A	Flare Traversable RT?	N/A
	N/A	Landing Length (in)	N/A	N/A	DWS Provided?	N/A
	N/A	Landing Width (in)	N/A	N/A	DWS Contrast?	N/A
	N/A	Landing Slope (%)	N/A	N/A	DWS Length (in)	N/A
	N/A	Landing X Slope (%)	N/A	N/A	DWS Full Width?	N/A
	N/A	Landing Curb? (Y/N)	N/A	N/A	DWS Offset (in)	N/A
	N/A	Shared Landing?	N/A			
	N/A	Gutter Ponding?	N/A	N/A	Gutter Slope (%)	N/A
	N/A	Gutter Lip Ht (in)	N/A	N/A	Gutter X Slope (%)	N/A
	N/A	Painted X Walk1?	Yes	N/A	Painted X Walk2?	Yes
		X Walk 1 Direction	To SE		X Walk 2 Direction	To NE
	N/A	X Walk 1 Width (in)	118.0	N/A	X Walk 2 Width (in)	120.0

X Walk 1 Slope (%)	0.7		X Walk 2 Slope (%)	1.8
		X Walk 1 X Slope (%)	1.3		X Walk 2 X Slope (%)	0.2
	N/A	Ramp inside XWalk1?	Yes	N/A	Ramp inside XWalk2?	Yes
		Road Slope (%)	1.8	N/A	Clear Space?	N/A
		Road X Slope (%)	0.3	N/A	Clear Space to XWalk (in)	N/A
	N/A	Any Obstructions?	N/A	N/A	Storm Grate/Utility Hazard?	N/A
		Obstruction Type		l	Storm Grate/Utility Type	
			N/A			N/A
				Yes	Surface Condition? (G/P)	Good
92

S DAVIDSON ST Street 1 Name Stop Condition-Street 2 Signal Street 2 Name E 3RD ST Stop Condition-Street 1 Signal Remove & Replace Curb Ramp With **Two New Directional Ramps or** Equivalent.

Not Found, R304.5.1, R304.5.3
