# Access Compliance Report

## Public Rights-of-Way

### (Curb Ramps)

Intersection ID: 10491	Main Street: FORESTBROOK_DR	Cross Street: TACOMA_ST	Location:	N/A
ADA ID: 386747A05940	Ramp Type: Perp	Initial Pass/Fail: Fail	Overall Compliance: No	Severity Score: 10
Codes/Mitigation Info/Possible Solution		Field Measurements/Component Compliance

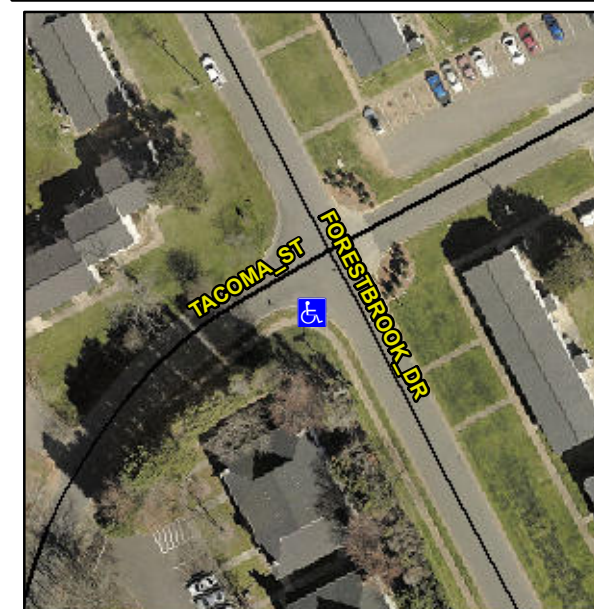
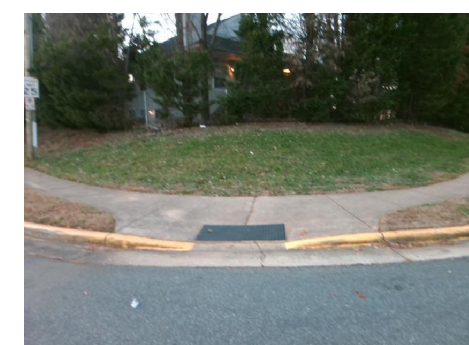
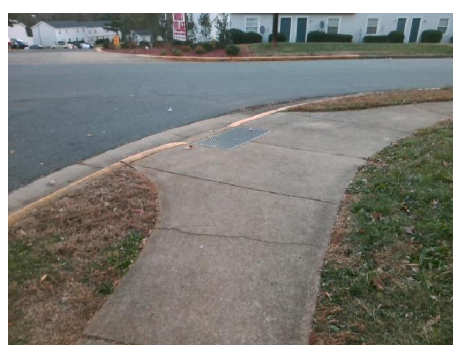
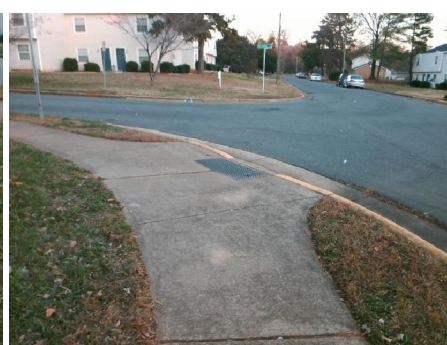
**Not Found, R304.5.1, R304.5.3**

Compliance	Description	Data	Compliance	Description	Data
N/A	Ramp Length (in)	53.0	Yes	Ramp Slope (%)	6.6
No	Ramp Width (in)	46.0	No	Ramp XSlope (%)	3.9
N/A	Flare Type LT	N/A	N/A	Flare Type RT	N/A
N/A	Flare Slope LT (%)	N/A	N/A	Flare Slope RT (%)	N/A
N/A	Flare Traversable LT?	N/A	N/A	Flare Traversable RT?	N/A
N/A	Landing Length (in)	N/A	N/A	DWS Provided?	N/A
N/A	Landing Width (in)	N/A	N/A	DWS Contrast?	N/A
N/A	Landing Slope (%)	N/A	N/A	DWS Length (in)	N/A
N/A	Landing X Slope (%)	N/A	N/A	DWS Full Width?	N/A
N/A	Landing Curb? (Y/N)	N/A	N/A	DWS Offset (in)	N/A
N/A	Shared Landing?	N/A			
N/A	Gutter Ponding?	N/A	N/A	Gutter Slope (%)	N/A
N/A	Gutter Lip Ht (in)	N/A	N/A	Gutter X Slope (%)	N/A
N/A	Painted X Walk1?	No	N/A	Painted X Walk2?	N/A
	X Walk 1 Direction	To E		X Walk 2 Direction	N/A
N/A	X Walk 1 Width (in)	N/A	N/A	X Walk 2 Width (in)	N/A
	X Walk 1 Slope (%)	1.5		X Walk 2 Slope (%)	N/A
	X Walk 1 X Slope (%)	2.5		X Walk 2 X Slope (%)	N/A

N/A	Ramp inside XWalk1?	N/A	N/A	Ramp inside XWalk2?	N/A
	Road Slope (%)	2.5	N/A	Clear Space?	N/A
	Road X Slope (%)	1.5	N/A	Clear Space to XWalk (in)	N/A
N/A	Any Obstructions?	N/A	N/A	Storm Grate/Utility Hazard?	N/A
	Obstruction Type			Storm Grate/Utility Type	
			N/A		N/A
			Yes	Surface Condition? (G/P)	Good

**Remove & Replace Entire Ramp.**

Total Cost: \$ 1850.00
