Access Compliance Report Public Rights-of-Way (Curb Ramps)

Intersection ID: 10034378 Main Street: PHILLIPS_PLACE_CT Cross Street: N/A Location: NE **Overall Compliance: No** ADA ID: 386E3007E912 Ramp Type: Perp Initial Pass/Fail: Fail **Severity Score:** 1.25

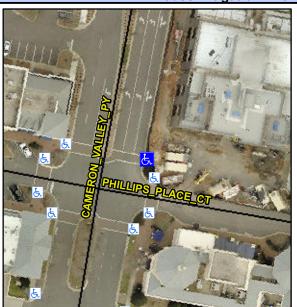
Field Measurements/Component Compliance							
Com	pliance Description	Data	Comp	oliance Description	Data		
N/A	Ramp Length (in)	72.0	Yes	Ramp Slope (%)	5.4		
Yes	Ramp Width (in)	106.5	No	Ramp XSlope (%)	3.3		
N/A	Flare Type LT	N/A	N/A	Flare Type RT	N/A		
N/A	Flare Slope LT (%)	N/A	N/A	Flare Slope RT (%)	N/A		
N/A	Flare Traversable LT?	N/A	N/A	Flare Traversable RT?	N/A		
N/A	Landing Length (in)	N/A	N/A	DWS Provided?	N/A		
N/A	Landing Width (in)	N/A	N/A	DWS Contrast?	N/A		
N/A	Landing Slope (%)	N/A	N/A	DWS Length (in)	N/A		
N/A	Landing X Slope (%)	N/A	N/A	DWS Full Width?	N/A		
N/A	Landing Curb? (Y/N)	N/A	N/A	DWS Offset (in)	N/A		
N/A	Shared Landing?	N/A					
N/A	Gutter Ponding?	N/A	N/A	Gutter Slope (%)	N/A		
N/A	Gutter Lip Ht (in)	1.0	N/A	Gutter X Slope (%)	N/A		
N/A	Painted X Walk1?	Yes	N/A	Painted X Walk2?	N/A		
	X Walk 1 Direction	To NW		X Walk 2 Direction	N/A		
N/A	X Walk 1 Width (in)	107.0	N/A	X Walk 2 Width (in)	N/A

X Walk 1 Slope (%)	1.3		X Walk 2 Slope (%)	N/A		
	X Walk 1 X Slope (%)	0.7		X Walk 2 X Slope (%)	N/A		
N/A	Ramp inside XWalk1?	Yes	N/A	Ramp inside XWalk2?	N/A		
	Road Slope (%)	N/A	N/A	Clear Space?	N/A		
	Road X Slope (%)	N/A	N/A	Clear Space to XWalk (in)	N/A		
N/A	Any Obstructions?	N/A	N/A	Storm Grate/Utility Hazard?	N/A		
	Obstruction Type			Storm Grate/Utility Type			
		N/A			N/A		
			Yes	Surface Condition? (G/P)	Good

Possible Solution			
Possible Solutions:	(
Remove & Replace Entire Ramp.			
·)		
	N		
	ı		
	1		
	ı		
Surveyor Notes:	ı		
N/A	ı		
	ı		
	1		
	1		
PROW/ADA:	ı		
R304.5.3	N		
	1		
	ı

Total Cost: 1850.00
