Access Compliance Report

Public Rights-of-Way

(Curb Ramps)

Intersection ID: 11892	Main Street: BOYER_ST	Cross Street: TAGGART_CREEK_RD	Location: NW
ADA ID: 3871B55BD264	Ramp Type: Perp	Initial Pass/Fail: Fail	Overall Compliance: No
Severity Score: 13.75			
Codes/Mitigation Info/Possible Solution		Field Measurements/Component Compliance

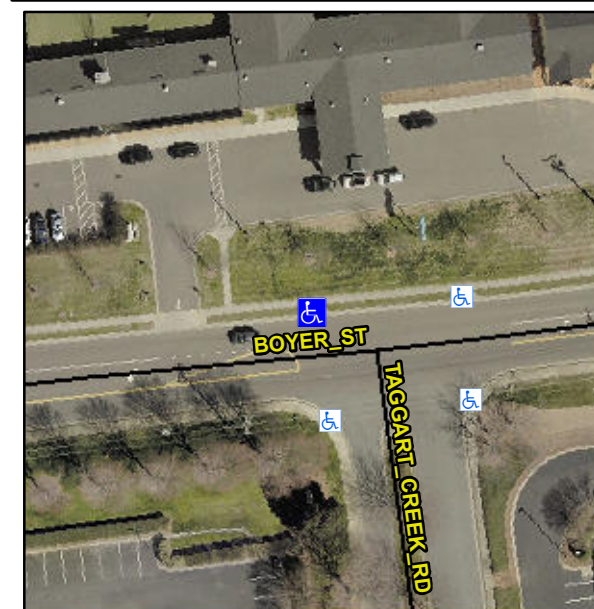
Compliance	Description	Data	Compliance	Description	Data
N/A	Ramp Length (in)	60.0	No	Ramp Slope (%)	9.1
Yes	Ramp Width (in)	48.0	Yes	Ramp XSlope (%)	2.1
N/A	Flare Type LT	N/A	N/A	Flare Type RT	N/A
N/A	Flare Slope LT (%)	N/A	N/A	Flare Slope RT (%)	N/A
N/A	Flare Traversable LT?	N/A	N/A	Flare Traversable RT?	N/A
N/A	Landing Length (in)	N/A	N/A	DWS Provided?	N/A
N/A	Landing Width (in)	N/A	N/A	DWS Contrast?	N/A
N/A	Landing Slope (%)	N/A	N/A	DWS Length (in)	N/A
N/A	Landing X Slope (%)	N/A	N/A	DWS Full Width?	N/A
N/A	Landing Curb? (Y/N)	N/A	N/A	DWS Offset (in)	N/A
N/A	Shared Landing?	N/A			
N/A	Gutter Ponding?	N/A	N/A	Gutter Slope (%)	N/A
N/A	Gutter Lip Ht (in)	N/A	N/A	Gutter X Slope (%)	N/A
N/A	Painted X Walk1?	No	N/A	Painted X Walk2?	N/A
	X Walk 1 Direction	To S		X Walk 2 Direction	N/A
N/A	X Walk 1 Width (in)	N/A	N/A	X Walk 2 Width (in)	N/A
	X Walk 1 Slope (%)	1.7		X Walk 2 Slope (%)	N/A
	X Walk 1 X Slope (%)	3.1		X Walk 2 X Slope (%)	N/A

N/A	Ramp inside XWalk1?	N/A	N/A	Ramp inside XWalk2?	N/A
	Road Slope (%)	N/A	N/A	Clear Space?	N/A
	Road X Slope (%)	N/A	N/A	Clear Space to XWalk (in)	N/A
N/A	Any Obstructions?	N/A	N/A	Storm Grate/Utility Hazard?	N/A
	Obstruction Type			Storm Grate/Utility Type	
		N/A			N/A
		Yes		Surface Condition? (G/P)	Good

Possible Solutions:

Remove & Replace Entire Ramp.

R304.2.2
