Access Compliance Report

Public Rights-of-Way

(Curb Ramps)

| Intersection ID: 9505 | Main Street: BUNGALOW_RD | Cross Street: CORONET_WY | Location: W |

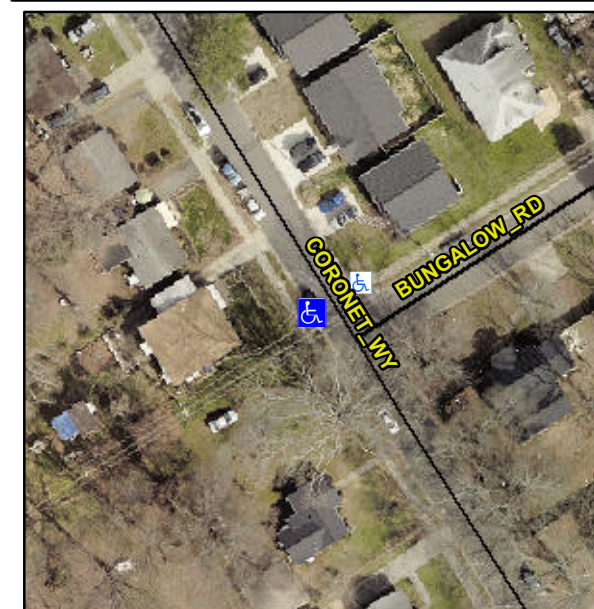
Not Found, R304.5.1, R304.5.3

| Compliance | Description | Data | Compliance | Description | Data |
|---|---|---|---|---|---|
| N/A | Ramp Length (in) | 68.5 | Yes | Ramp Slope (%) | 5.0 |
| No | Ramp Width (in) | 47.5 | No | Ramp XSlope (%) | 7.1 |

Remove & Replace Entire Ramp.
