Access Compliance Report Public Rights-of-Way (Curb Ramps)

Intersection ID: 12896 Main Street: E_6TH_ST Cross Street: N_MCDOWELL_ST Location: W ADA ID: 387B1AC6353C Ramp Type: PerpDiag Initial Pass/Fail: Fail **Overall Compliance: No Severity Score:** 12.5

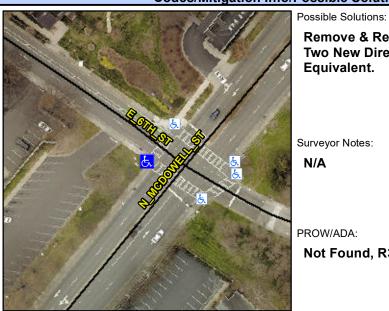
Data		Compliance Description	
N/A	Ramp Length (in)	72.0	No	Ramp Slope (%)	9.2
Yes	Ramp Width (in)	48.0	Yes	Ramp XSlope (%)	0.5
N/A	Flare Type LT	N/A	N/A	Flare Type RT	N/A
N/A	Flare Slope LT (%)	N/A	N/A	Flare Slope RT (%)	N/A
N/A	Flare Traversable LT?	N/A	N/A	Flare Traversable RT?	N/A
N/A	Landing Length (in)	N/A	N/A	DWS Provided?	N/A
N/A	Landing Width (in)	N/A	N/A	DWS Contrast?	N/A
N/A	Landing Slope (%)	N/A	N/A	DWS Length (in)	N/A
N/A	Landing X Slope (%)	N/A	N/A	DWS Full Width?	N/A
N/A	Landing Curb? (Y/N)	N/A	N/A	DWS Offset (in)	N/A
N/A	Shared Landing?	N/A			
N/A	Gutter Ponding?	N/A	N/A	Gutter Slope (%)	N/A
N/A	Gutter Lip Ht (in)	N/A	N/A	Gutter X Slope (%)	N/A
N/A	Painted X Walk1?	Yes	N/A	Painted X Walk2?	Yes
	X Walk 1 Direction	To SE		X Walk 2 Direction	To NE
N/A	X Walk 1 Width (in)	115.0	N/A	X Walk 2 Width (in)	108.0
	X Walk 1 Slope (%)	0.2		X Walk 2 Slope (%)	3.4
	X Walk 1 X Slope (%)	0.6		X Walk 2 X Slope (%)	2.5

N/A	Ramp inside XWalk1?	Yes	N/A	Ramp inside XWalk2?	Yes
	Road Slope (%)	1.5	N/A	Clear Space?	N/A
	Road X Slope (%)	0.2	N/A	Clear Space to XWalk (in)	N/A
N/A	Any Obstructions?	N/A	N/A	Storm Grate/Utility Hazard?	N/A
	Obstruction Type			Storm Grate/Utility Type	
		N/A			N/A
			Yes	Surface Condition? (G/P)	Good

Remove & Replace Curb Ramp With **Two New Directional Ramps or** Equivalent.

und, R304.2.2

3200.00 Total Cost:
