Access Compliance Report

Public Rights-of-Way

(Curb Ramps)

| Intersection ID: 49303 | Main Street: ARDREY_CREST_DR | Cross Street: WADE_ARDREY_RD | Location: SE |

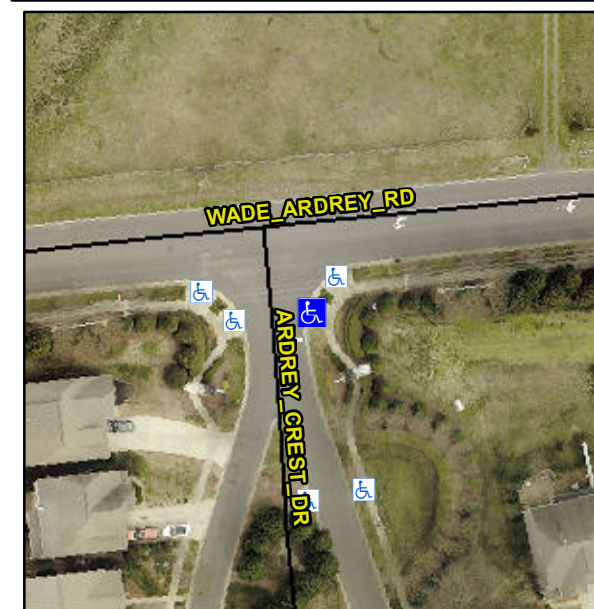
Not Found, R304.5.3

| Compliance | Description | Data | Compliance | Description | Data |
|---|---|---|---|---|---|
| N/A | Ramp Length (in) | 96.0 | Yes | Ramp Slope (%) | 7.4 |
| Yes | Ramp Width (in) | 48.0 | No | Ramp XSlope (%) | 3.4 |

Remove & Replace Entire Ramp.
