# Access Compliance Report

## Public Rights-of-Way

### (Curb Ramps)

| Intersection ID: 46182 | Main Street: SEVEN_OAKS_DR | Cross Street: GLOXINIA_RD | Location: NE |

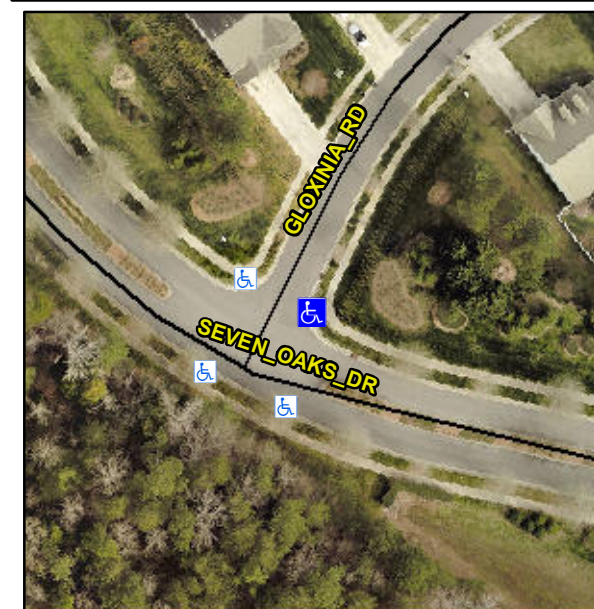
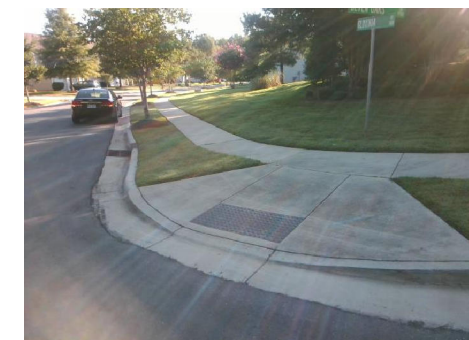
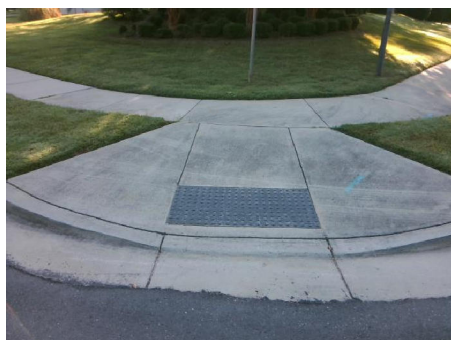
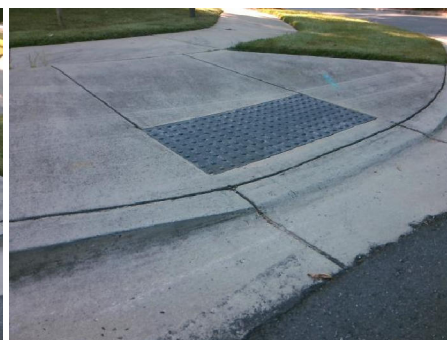
| ADA ID: 389DE5D4C5F3 | Ramp Type: PerpDiag | Initial Pass/Fail: Fail | Overall Compliance: No |

**Not Found, R304.5.1, R304.5.3**

| Compliance | Description | Data | Compliance | Description | Data |
|---|---|---|---|---|---|
| N/A | Ramp Length (in) | 97.0 | Yes | Ramp Slope (%) | 7.1 |
| No | Ramp Width (in) | 47.0 | No | Ramp XSlope (%) | 2.1 |

**Remove & Replace Curb Ramp With Two New Directional Ramps or Equivalent.**
