Access Compliance Report

Public Rights-of-Way

(Curb Ramps)

Intersection ID: 16133	Main Street: E_W_T_HARRIS_BV	Cross Street: IDLEWILD_RD_NORTH	Location: SE
ADA ID: 389E1504CFAF	Ramp Type: Perp	Initial Pass/Fail: Fail	Overall Compliance: No
Severity Score: 21.25			
Codes/Mitigation Info/Possible Solution		Field Measurements/Component Compliance

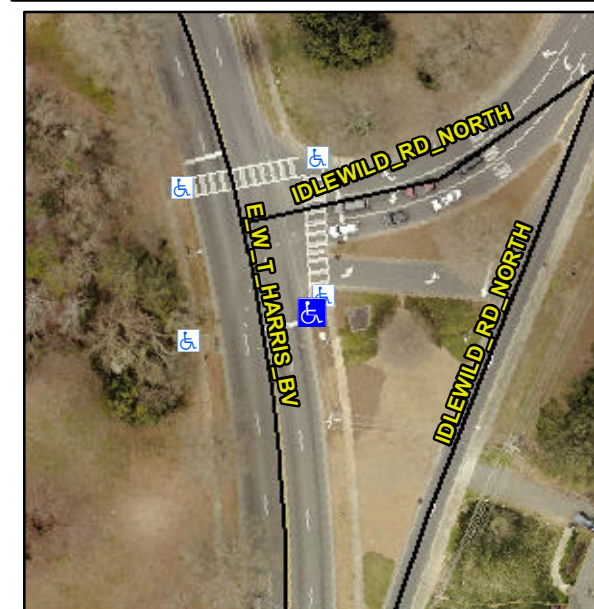
Not Found, R304.5.1, R304.2.2

Compliance	Description	Data	Compliance	Description	Data
N/A	Ramp Length (in)	64.0	No	Ramp Slope (%)	10.9
No	Ramp Width (in)	37.0	Yes	Ramp XSlope (%)	0.5
N/A	Flare Type LT	N/A	N/A	Flare Type RT	N/A
N/A	Flare Slope LT (%)	N/A	N/A	Flare Slope RT (%)	N/A
N/A	Flare Traversable LT?	N/A	N/A	Flare Traversable RT?	N/A
N/A	Landing Length (in)	N/A	N/A	DWS Provided?	N/A
N/A	Landing Width (in)	N/A	N/A	DWS Contrast?	N/A
N/A	Landing Slope (%)	N/A	N/A	DWS Length (in)	N/A
N/A	Landing X Slope (%)	N/A	N/A	DWS Full Width?	N/A
N/A	Landing Curb? (Y/N)	N/A	N/A	DWS Offset (in)	N/A
N/A	Shared Landing?	N/A			
N/A	Gutter Ponding?	N/A	N/A	Gutter Slope (%)	N/A
N/A	Gutter Lip Ht (in)	N/A	N/A	Gutter X Slope (%)	N/A
N/A	Painted X Walk1?	No	N/A	Painted X Walk2?	N/A
	X Walk 1 Direction	To W		X Walk 2 Direction	N/A
N/A	X Walk 1 Width (in)	N/A	N/A	X Walk 2 Width (in)	N/A
	X Walk 1 Slope (%)	1.9		X Walk 2 Slope (%)	N/A
	X Walk 1 X Slope (%)	2.6		X Walk 2 X Slope (%)	N/A

N/A	Ramp inside XWalk1?	N/A	N/A	Ramp inside XWalk2?	N/A
	Road Slope (%)	N/A	N/A	Clear Space?	N/A
	Road X Slope (%)	N/A	N/A	Clear Space to XWalk (in)	N/A
N/A	Any Obstructions?	N/A	N/A	Storm Grate/Utility Hazard?	N/A
	Obstruction Type			Storm Grate/Utility Type	
		N/A			N/A
			Yes	Surface Condition? (G/P)	Good

Remove & Replace Entire Ramp.
