Access Compliance Report

Public Rights-of-Way

(Curb Ramps)

Intersection ID: 15070	Main Street: IDEAL_WY	Cross Street: REMOUNT_RD	Location:	N
ADA ID: 38A691E5F849	Ramp Type: Perp	Initial Pass/Fail: Fail	Overall Compliance: No	Severity Score: 21.25
Codes/Mitigation Info/Possible Solution		Field Measurements/Component Compliance

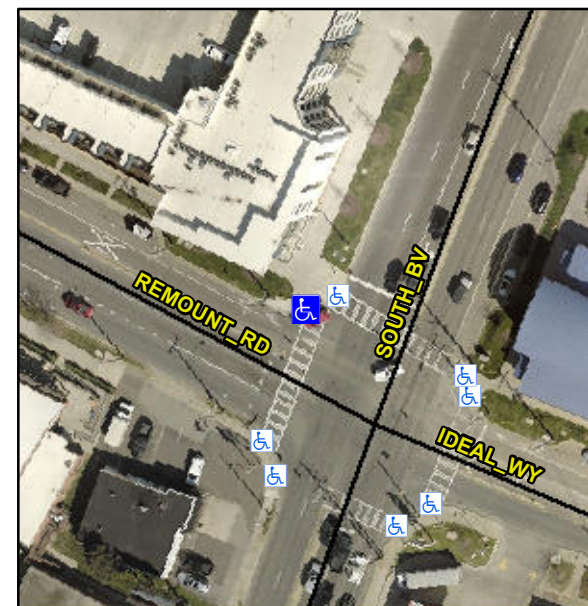
Not Found, R304.5.1, R304.2.2

Compliance	Description	Data	Compliance	Description	Data
N/A	Ramp Length (in)	71.0	No	Ramp Slope (%)	8.9
No	Ramp Width (in)	42.0	Yes	Ramp XSlope (%)	1.6
N/A	Flare Type LT	N/A	N/A	Flare Type RT	N/A
N/A	Flare Slope LT (%)	N/A	N/A	Flare Slope RT (%)	N/A
N/A	Flare Traversable LT?	N/A	N/A	Flare Traversable RT?	N/A
N/A	Landing Length (in)	N/A	N/A	DWS Provided?	N/A
N/A	Landing Width (in)	N/A	N/A	DWS Contrast?	N/A
N/A	Landing Slope (%)	N/A	N/A	DWS Length (in)	N/A
N/A	Landing X Slope (%)	N/A	N/A	DWS Full Width?	N/A
N/A	Landing Curb? (Y/N)	N/A	N/A	DWS Offset (in)	N/A
N/A	Shared Landing?	N/A			
N/A	Gutter Ponding?	N/A	N/A	Gutter Slope (%)	N/A
N/A	Gutter Lip Ht (in)	N/A	N/A	Gutter X Slope (%)	N/A
N/A	Painted X Walk1?	Yes	N/A	Painted X Walk2?	N/A
	X Walk 1 Direction	To SW		X Walk 2 Direction	N/A
N/A	X Walk 1 Width (in)	118.0	N/A	X Walk 2 Width (in)	N/A
	X Walk 1 Slope (%)	0.5		X Walk 2 Slope (%)	N/A
	X Walk 1 X Slope (%)	1.6		X Walk 2 X Slope (%)	N/A

N/A	Ramp inside XWalk1?	Yes	N/A	Ramp inside XWalk2?	N/A
	Road Slope (%)	N/A	N/A	Clear Space?	N/A
	Road X Slope (%)	N/A	N/A	Clear Space to XWalk (in)	N/A
N/A	Any Obstructions?	N/A	N/A	Storm Grate/Utility Hazard?	N/A
	Obstruction Type			Storm Grate/Utility Type	
		N/A			N/A
		Yes		Surface Condition? (G/P)	Good

Possible Solutions:

Remove & Replace Entire Ramp.
