# Access Compliance Report

## Public Rights-of-Way

### (Curb Ramps)

| Intersection ID: 31251 | Main Street: MORNINGVIEW_CT | Cross Street: SUNSET_RIDGE_CT | Location: SE |

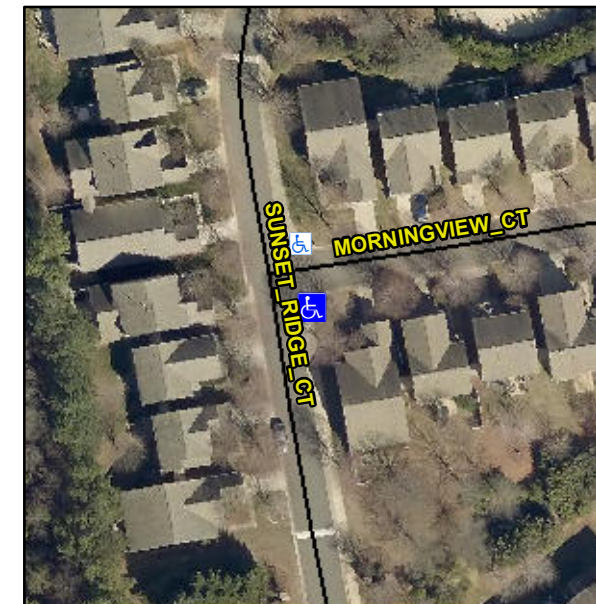
**Not Found, R304.5.1**

| Compliance | Description | Data | Compliance | Description | Data |
|---|---|---|---|---|---|
| No | Ramp Width (in) | 46.5 | Yes | Ramp XSlope (%) | 0.4 |

**Remove & Replace Entire Ramp.**
