Access Compliance Report Public Rights-of-Way (Curb Ramps)

| Intersection ID: 10038782 Main Str | ID: 10038782 Main Street: STEELE_CREEK_RD | | Cross Street: N/A | | | | | SW |
| DA ID: 38B123DB9E00 Ramp Type: PerpDiag | | Initial Pass/Fail: Fail Overall Compliance: No | | | | o Severity Score: | 21.25 | |

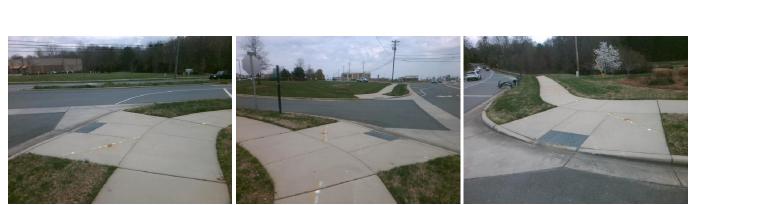
| Intersection ID: 10038782 Main Str | ID: 10038782 Main Street: STEELE_CREEK_RD | | Cross Street: N/A | | | | | SW |
|---|---|--|---|---|---|---|---|---|
| | Remove & Replace Curb Ramp Wir Two New Directional Ramps or Equivalent. | /ith N | /A | Ramp Length (in) | 84.0 | No | Ramp Slope (%) | 8.7 |
| | | N | o | Ramp Width (in) | 47.0 | Yes | Ramp XSlope (%) | 1.4 |
| | Not Found, R304.5.1, R304.2.2 | N | / A | Gutter Lip Ht (in) | N/A | N/A | Gutter X Slope (%) | N/A |

| Intersection ID: 10038782 Main Str | ID: 10038782 Main Street: STEELE_CREEK_RD | | Cross Street: N/A | | | | | SW |
|---|---|--|---|---|---|---|---|---|
| | Total Cost: \$ 32 | 200.00 | | Obstruction Type | | | Storm Grate/Utility Type | |
