Access Compliance Report

Public Rights-of-Way

(Curb Ramps)

Intersection ID: 16298	Main Street: W_TYVOLA_RD	Cross Street: YORKMONT_RD	Location: NW
ADA ID: 38B79BE0C531	Ramp Type: Perp	Initial Pass/Fail: Fail	Overall Compliance: No
Codes/Mitigation Info/Possible Solution		Field Measurements/Component Compliance	
Severity Score: 10

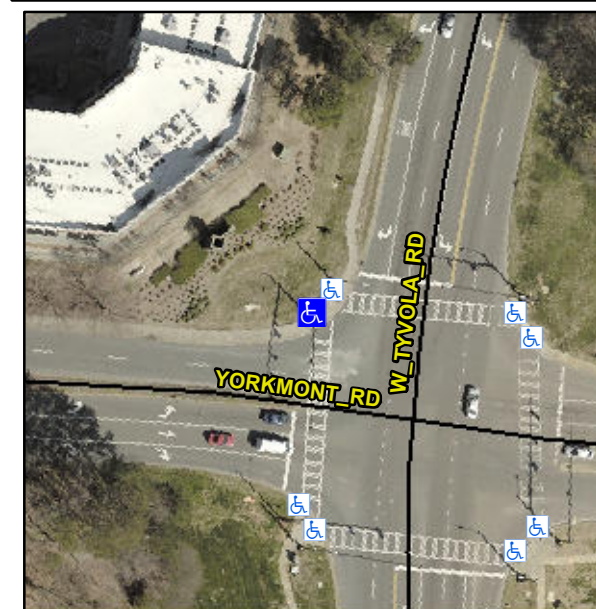
Not Found, R304.5.1

Compliance	Description	Data	Compliance	Description	Data
N/A	Ramp Length (in)	59.5	Yes	Ramp Slope (%)	7.1
No	Ramp Width (in)	46.0	Yes	Ramp XSlope (%)	4.8
N/A	Flare Type LT	N/A	N/A	Flare Type RT	N/A
N/A	Flare Slope LT (%)	N/A	N/A	Flare Slope RT (%)	N/A
N/A	Flare Traversable LT?	N/A	N/A	Flare Traversable RT?	N/A
N/A	Landing Length (in)	N/A	N/A	DWS Provided?	N/A
N/A	Landing Width (in)	N/A	N/A	DWS Contrast?	N/A
N/A	Landing Slope (%)	N/A	N/A	DWS Length (in)	N/A
N/A	Landing X Slope (%)	N/A	N/A	DWS Full Width?	N/A
N/A	Landing Curb? (Y/N)	N/A	N/A	DWS Offset (in)	N/A
N/A	Shared Landing?	N/A			
N/A	Gutter Ponding?	N/A	N/A	Gutter Slope (%)	N/A
N/A	Gutter Lip Ht (in)	N/A	N/A	Gutter X Slope (%)	N/A
N/A	Painted X Walk1?	Yes	N/A	Painted X Walk2?	N/A
	X Walk 1 Direction	To S		X Walk 2 Direction	N/A
N/A	X Walk 1 Width (in)	107.0	N/A	X Walk 2 Width (in)	N/A
	X Walk 1 Slope (%)	0.6		X Walk 2 Slope (%)	N/A
	X Walk 1 X Slope (%)	5.7		X Walk 2 X Slope (%)	N/A

N/A	Ramp inside XWalk1?	Yes	N/A	Ramp inside XWalk2?	N/A
	Road Slope (%)	N/A	N/A	Clear Space?	N/A
	Road X Slope (%)	N/A	N/A	Clear Space to XWalk (in)	N/A
N/A	Any Obstructions?	N/A	N/A	Storm Grate/Utility Hazard?	N/A
	Obstruction Type			Storm Grate/Utility Type	
		N/A			N/A
		Yes		Surface Condition? (G/P)	Good

Possible Solutions:

Remove & Replace Entire Ramp.

Total Cost: \$ 1850.00
