Access Compliance Report

Public Rights-of-Way

(Curb Ramps)

Intersection ID: 12347	Main Street: S_CHURCH_ST	Cross Street: W_3RD_ST	Location: S
ADA ID: 38B7F908225C	Ramp Type: BlendTrans1	Initial Pass/Fail: Pass	Overall Compliance: No
Codes/Mitigation Info/Possible Solution		Field Measurements/Component Compliance	
Severity Score: 0

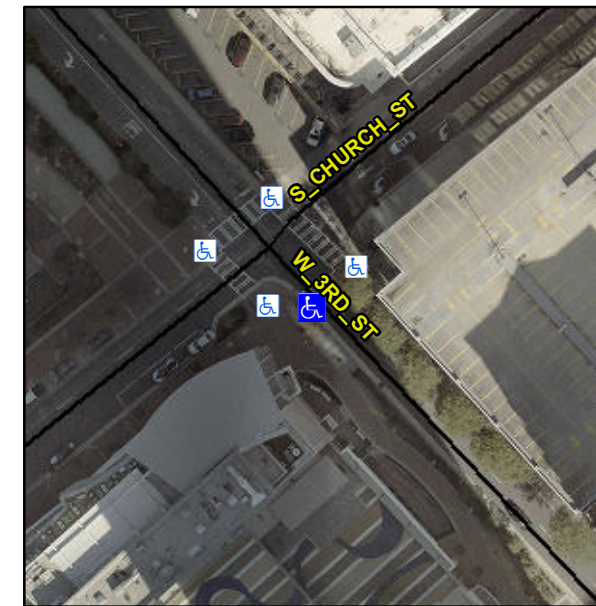
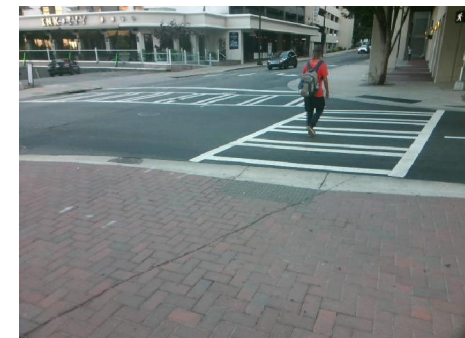
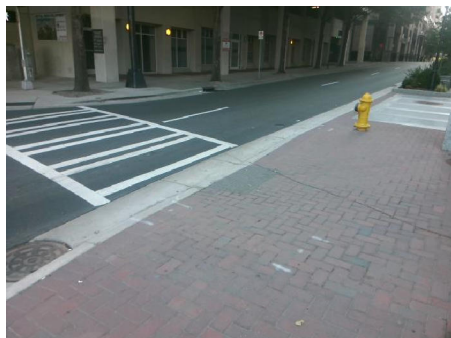
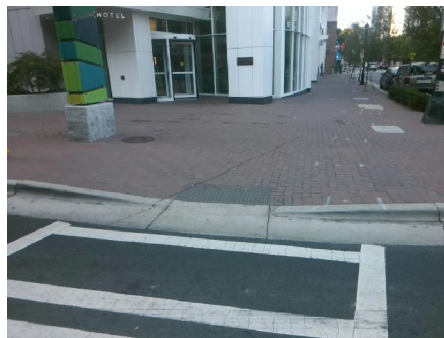
Not Found, R304.5.3

Compliance	Description	Data	Compliance	Description	Data
N/A	Ramp Length (in)	24.0	Yes	BlendTrans Slope (%)	2.8
Yes	Ramp Width (in)	48.0	Yes	BlendTrans XSlope (%)	1.2
N/A	Flare Type LT	Sloped	N/A	Flare Type RT	Sloped
Yes	Flare Slope LT (%)	8.7	Yes	Flare Slope RT (%)	3.7
N/A	Flare Traversable LT?	Yes	N/A	Flare Traversable RT?	Yes
Yes	Landing Length (in)	60.0	Yes	DWS Provided?	Yes
Yes	Landing Width (in)	60.0	Yes	DWS Contrast?	Yes
Yes	Landing Slope (%)	1.5	Yes	DWS Length (in)	24.0
Yes	Landing X Slope (%)	1.5	Yes	DWS Full Width?	Yes
N/A	Landing Curb? (Y/N)	No	Yes	DWS Offset (in)	0.0
N/A	Shared Landing?	No			
Yes	Gutter Ponding?	No	Yes	Gutter Slope (%)	2.4
Yes	Gutter Lip Ht (in)	0.0	No	Gutter X Slope (%)	4.1
N/A	Painted X Walk1?	Yes	N/A	Painted X Walk2?	N/A
	X Walk 1 Direction	To NE		X Walk 2 Direction	N/A
	X Walk 1 Width (in)	116.0		X Walk 2 Width (in)	N/A
	X Walk 1 Slope (%)	2.0		X Walk 2 Slope (%)	N/A
	X Walk 1 X Slope (%)	3.2		X Walk 2 X Slope (%)	N/A

Yes	Ramp inside XWalk1?	Yes	N/A	Ramp inside XWalk2?	N/A
	Road Slope (%)	3.2		Clear Space?	Yes
	Road X Slope (%)	2.0	N/A	Clear Space to XWalk (in)	N/A
Yes	Any Obstructions?	No	Yes	Storm Grate/Utility Hazard?	No
	Obstruction Type			Storm Grate/Utility Type	
		N/A			N/A
			Yes	Surface Condition? (G/P)	Good
			No	Curb Slope (%)	12.7

Remove & Replace Curb Slope and Extend Ramp. Remove & Replace Gutter.
