Access Compliance Report

Public Rights-of-Way

(Curb Ramps)

Intersection ID: 50664	Main Street: WITHERS_RD	Cross Street: CRAIGHILL_LN	Location: NW
ADA ID: 38B8DB644204	Ramp Type: Perp	Initial Pass/Fail: Fail	Overall Compliance: No
Severity Score: 8.75			
Codes/Mitigation Info/Possible Solution		Field Measurements/Component Compliance

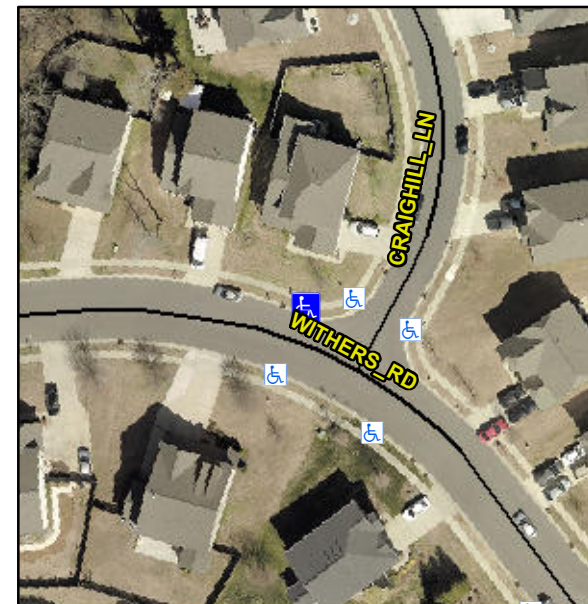
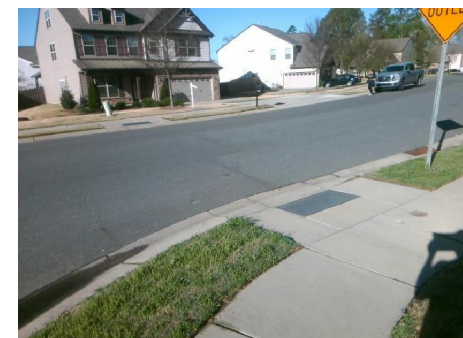
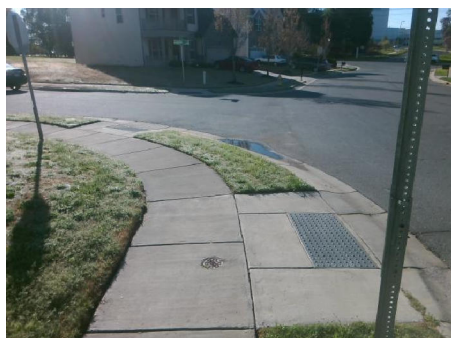
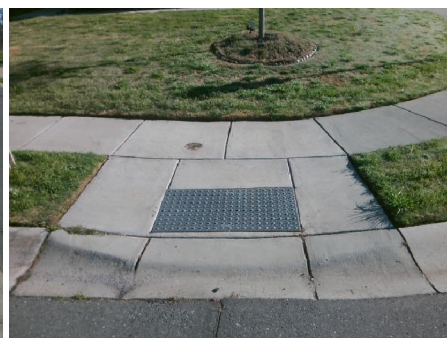
PROW/ADA:

R304.5.1

Compliance	Description	Data	Compliance	Description	Data
N/A	Ramp Length (in)	50.0	Yes	Ramp Slope (%)	7.8
No	Ramp Width (in)	47.0	Yes	Ramp XSlope (%)	1.5
N/A	Flare Type LT	N/A	N/A	Flare Type RT	N/A
N/A	Flare Slope LT (%)	N/A	N/A	Flare Slope RT (%)	N/A
N/A	Flare Traversable LT?	N/A	N/A	Flare Traversable RT?	N/A
N/A	Landing Length (in)	N/A	N/A	DWS Provided?	N/A
N/A	Landing Width (in)	N/A	N/A	DWS Contrast?	N/A
N/A	Landing Slope (%)	N/A	N/A	DWS Length (in)	N/A
N/A	Landing X Slope (%)	N/A	N/A	DWS Full Width?	N/A
N/A	Landing Curb? (Y/N)	N/A	N/A	DWS Offset (in)	N/A
N/A	Shared Landing?	N/A			
N/A	Gutter Ponding?	N/A	N/A	Gutter Slope (%)	N/A
N/A	Gutter Lip Ht (in)	N/A	N/A	Gutter X Slope (%)	N/A
N/A	Painted X Walk1?	No	N/A	Painted X Walk2?	N/A
	X Walk 1 Direction	To SW		X Walk 2 Direction	N/A
N/A	X Walk 1 Width (in)	N/A	N/A	X Walk 2 Width (in)	N/A
	X Walk 1 Slope (%)	1.6		X Walk 2 Slope (%)	N/A
	X Walk 1 X Slope (%)	3.8		X Walk 2 X Slope (%)	N/A

N/A	Ramp inside XWalk1?	N/A	N/A	Ramp inside XWalk2?	N/A
	Road Slope (%)	N/A	N/A	Clear Space?	N/A
	Road X Slope (%)	N/A	N/A	Clear Space to XWalk (in)	N/A
N/A	Any Obstructions?	N/A	N/A	Storm Grate/Utility Hazard?	N/A
	Obstruction Type			Storm Grate/Utility Type	
		N/A			N/A
			Yes	Surface Condition? (G/P)	Good

Possible Solutions:

Remove & Replace Entire Ramp.

Total Cost: \$ 1850.00
