Access Compliance Report

Public Rights-of-Way

(Curb Ramps)

Intersection ID: 30419	Main Street: ELM_BEND_DR	Cross Street: FENWAY_DR	Location: NE
ADA ID: 38BEC942D212	Ramp Type: Perp	Initial Pass/Fail: Fail	Overall Compliance: No
			Severity Score: 21.25

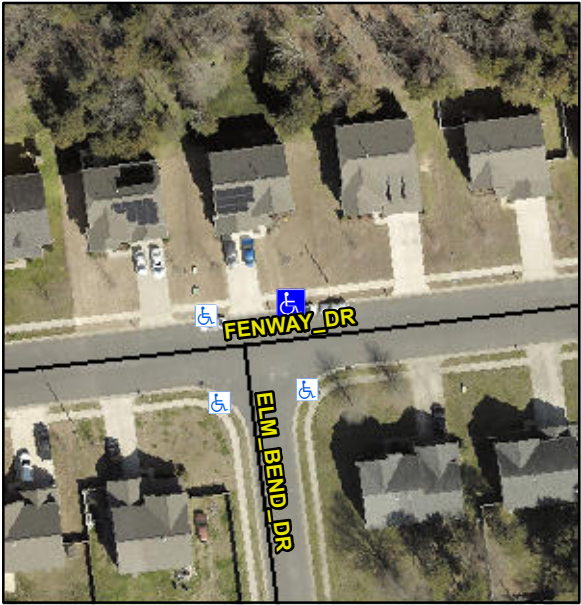
Possible Solutions:	Compliance	Description	Data	Compliance	Description	Data
	Remove & Replace Entire Ramp.	N/A	Ramp Length (in)	47.0	No	Ramp Slope (%)	8.7
		No	Ramp Width (in)	47.0	Yes	Ramp XSlope (%)	1.5
		N/A	Flare Type LT	N/A	N/A	Flare Type RT	N/A
		N/A	Flare Slope LT (%)	N/A	N/A	Flare Slope RT (%)	N/A
		N/A	Flare Traversable LT?	N/A	N/A	Flare Traversable RT?	N/A
		N/A	Landing Length (in)	N/A	N/A	DWS Provided?	N/A
		N/A	Landing Width (in)	N/A	N/A	DWS Contrast?	N/A
		N/A	Landing Slope (%)	N/A	N/A	DWS Length (in)	N/A
		N/A	Landing X Slope (%)	N/A	N/A	DWS Full Width?	N/A
		N/A	Landing Curb? (Y/N)	N/A	N/A	DWS Offset (in)	N/A
		N/A	Shared Landing?	N/A			
		N/A	Gutter Ponding?	N/A	N/A	Gutter Slope (%)	N/A
		N/A	Gutter Lip Ht (in)	N/A	N/A	Gutter X Slope (%)	N/A
		N/A	Painted X Walk1?	No	N/A	Painted X Walk2?	N/A
			X Walk 1 Direction	To S		X Walk 2 Direction	N/A

N/A	X Walk 1 Width (in)	N/A	N/A	X Walk 2 Width (in)	N/A
			X Walk 1 Slope (%)	2.0		X Walk 2 Slope (%)	N/A
			X Walk 1 X Slope (%)	0.5		X Walk 2 X Slope (%)	N/A
		N/A	Ramp inside XWalk1?	N/A	N/A	Ramp inside XWalk2?	N/A
<p>Surveyor Notes:</p> <p>N/A</p> <p>PROW/ADA:</p> <p>R304.5.1, R304.2.2</p>			Road Slope (%)	N/A	N/A	Clear Space?	N/A
			Road X Slope (%)	N/A	N/A	Clear Space to XWalk (in)	N/A
		N/A	Any Obstructions?	N/A	N/A	Storm Grate/Utility Hazard?	N/A
			Obstruction Type			Storm Grate/Utility Type	
					N/A		N/A
					Yes	Surface Condition? (G/P)	Good
