# Access Compliance Report

## Public Rights-of-Way

### (Curb Ramps)

Intersection ID: 30229	Main Street: LEECREST_DR	Cross Street: RUCKER_CLIFF_DR	Location: W
ADA ID: 38E4215BDB18	Ramp Type: BlendTrans1	Initial Pass/Fail: Fail	Overall Compliance: No
Severity Score: 21.25			
Codes/Mitigation Info/Possible Solution		Field Measurements/Component Compliance

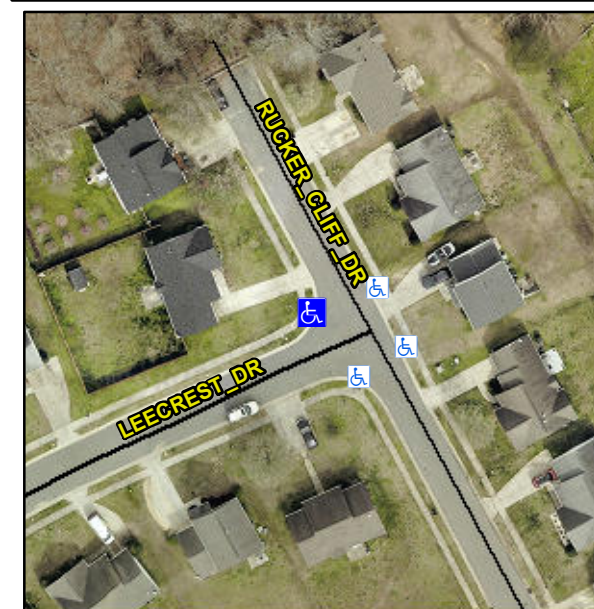
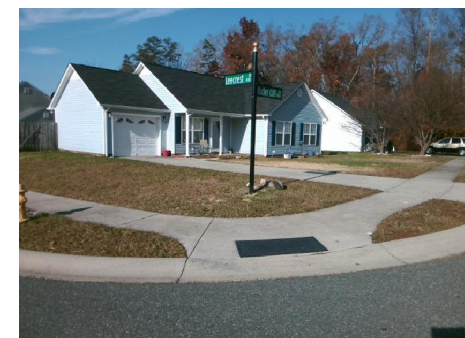
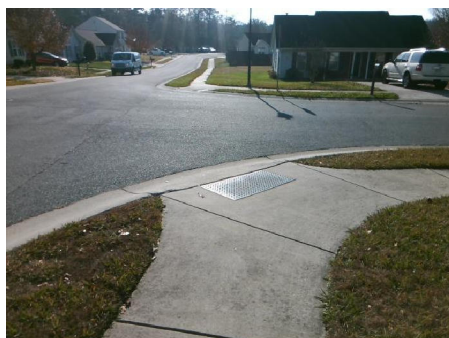
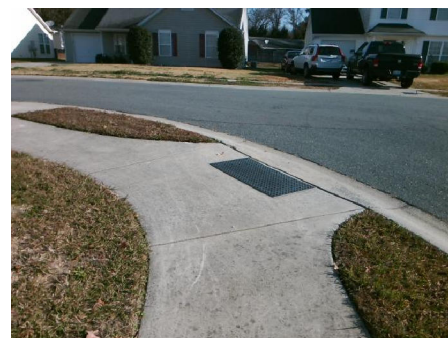
Surveyor Notes:

**CURB GAP 1.0**

PROW/ADA:

**Not Found, R304.5.1, R304.5.3**

Compliance	Description	Data	Compliance	Description	Data
N/A	Ramp Length (in)	81.0	Yes	BlendTrans Slope (%)	2.4
No	Ramp Width (in)	47.5	No	BlendTrans XSlope (%)	5.2
N/A	Flare Type LT	N/A	N/A	Flare Type RT	N/A
N/A	Flare Slope LT (%)	N/A	N/A	Flare Slope RT (%)	N/A
N/A	Flare Traversable LT?	N/A	N/A	Flare Traversable RT?	N/A
N/A	Landing Length (in)	N/A	N/A	DWS Provided?	N/A
N/A	Landing Width (in)	N/A	N/A	DWS Contrast?	N/A
N/A	Landing Slope (%)	N/A	N/A	DWS Length (in)	N/A
N/A	Landing X Slope (%)	N/A	N/A	DWS Full Width?	N/A
N/A	Landing Curb? (Y/N)	N/A	N/A	DWS Offset (in)	N/A
N/A	Shared Landing?	N/A			
N/A	Gutter Ponding?	N/A	N/A	Gutter Slope (%)	N/A
N/A	Gutter Lip Ht (in)	N/A	N/A	Gutter X Slope (%)	N/A
N/A	Painted X Walk1?	No	N/A	Painted X Walk2?	No
	X Walk 1 Direction	To SE		X Walk 2 Direction	To NE
	X Walk 1 Width (in)	N/A		X Walk 2 Width (in)	N/A
	X Walk 1 Slope (%)	2.4		X Walk 2 Slope (%)	7.3
	X Walk 1 X Slope (%)	4.7		X Walk 2 X Slope (%)	2.3

N/A	Ramp inside XWalk1?	N/A	N/A	Ramp inside XWalk2?	N/A
	Road Slope (%)	3.9		Clear Space?	N/A
	Road X Slope (%)	4.1	N/A	Clear Space to XWalk (in)	N/A
N/A	Any Obstructions?	N/A	N/A	Storm Grate/Utility Hazard?	N/A
	Obstruction Type			Storm Grate/Utility Type	
		N/A			N/A
			Yes	Surface Condition? (G/P)	Good
			No	Curb Slope (%)	5.8

Possible Solutions:

**Remove & Replace Curb Ramp With Two New Directional Ramps or Equivalent.**

Total Cost: \$ 3200.00
