## Access Compliance Report Public Rights-of-Way (Curb Ramps)

Intersection ID: 9344Main Street:LITTLE\_HAMPTON\_PLCross Street:MILSTEAD\_CTLocation:SWADA ID: 38EE002D2D53Ramp Type:PerpInitial Pass/Fail:FailOverall Compliance:NoSeverity Score:8.75

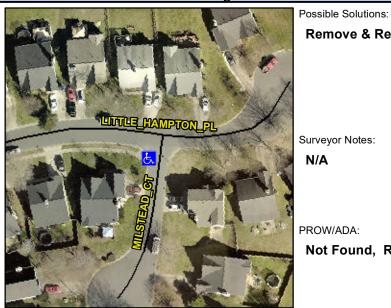
Comp	liance Description	Data	Comp	liance Description	Data
N/A	Ramp Length (in)	49.0	Yes	Ramp Slope (%)	8.1
No	Ramp Width (in)	46.0	Yes	Ramp XSlope (%)	0.3
N/A	Flare Type LT	N/A	N/A	Flare Type RT	N/A
N/A	Flare Slope LT (%)	N/A	N/A	Flare Slope RT (%)	N/A
N/A	Flare Traversable LT?	N/A	N/A	Flare Traversable RT?	N/A
N/A	Landing Length (in)	N/A	N/A	DWS Provided?	N/A
N/A	Landing Width (in)	N/A	N/A	DWS Contrast?	N/A
N/A	Landing Slope (%)	N/A	N/A	DWS Length (in)	N/A
N/A	Landing X Slope (%)	N/A	N/A	DWS Full Width?	N/A
N/A	Landing Curb? (Y/N)	N/A	N/A	DWS Offset (in)	N/A
N/A	Shared Landing?	N/A			
N/A	Gutter Ponding?	Yes	N/A	Gutter Slope (%)	N/A
N/A	Gutter Lip Ht (in)	N/A	N/A	Gutter X Slope (%)	N/A
N/A	Painted X Walk1?	No	N/A	Painted X Walk2?	N/A
	X Walk 1 Direction	To NE		X Walk 2 Direction	N/A
N/A	X Walk 1 Width (in)	N/A	N/A	X Walk 2 Width (in)	N/A
	X Walk 1 Slope (%)	0.8		X Walk 2 Slope (%)	N/A
	X Walk 1 X Slope (%)	0.3		X Walk 2 X Slope (%)	N/A

N/A	Ramp inside XWalk1?	N/A	N/A	Ramp inside XWalk2?	N/A
	Road Slope (%)	N/A	N/A	Clear Space?	N/A
	Road X Slope (%)	N/A	N/A	Clear Space to XWalk (in)	N/A
N/A	Any Obstructions?	N/A	N/A	Storm Grate/Utility Hazard?	N/A
	Obstruction Type			Storm Grate/Utility Type	
		N/A			N/A
			Yes	Surface Condition? (G/P)	Good

Remove & Replace Entire Ramp.	
	N
	N
	N
	N
	N
Surveyor Notes:	N
N/A	N
	N
	N
	N
PROW/ADA:	N
Not Found, R304.5.1	N
	N
	N
	N
