Access Compliance Report

Public Rights-of-Way

(Curb Ramps)

Intersection ID: 27871	Main Street: HARRISON'S_CROSSING_AV	Cross Street: STRICKLAND_CT	Location:	N
ADA ID: 38F1DB37A8A7	Ramp Type: Perp	Initial Pass/Fail: Fail	Overall Compliance: No	Severity Score: 13.75
Codes/Mitigation Info/Possible Solution		Field Measurements/Component Compliance

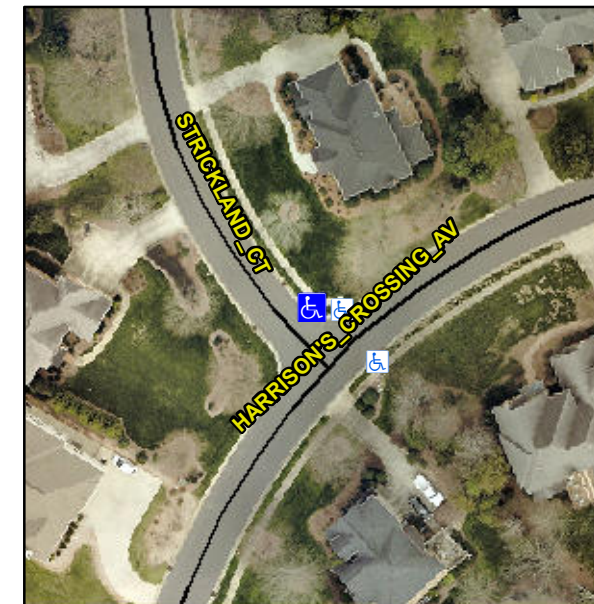
Not Found, R304.2.2, R304.5.3

Compliance	Description	Data	Compliance	Description	Data
N/A	Ramp Length (in)	52.0	No	Ramp Slope (%)	10.0
Yes	Ramp Width (in)	48.0	No	Ramp XSlope (%)	3.1
N/A	Flare Type LT	N/A	N/A	Flare Type RT	N/A
N/A	Flare Slope LT (%)	N/A	N/A	Flare Slope RT (%)	N/A
N/A	Flare Traversable LT?	N/A	N/A	Flare Traversable RT?	N/A
N/A	Landing Length (in)	N/A	N/A	DWS Provided?	N/A
N/A	Landing Width (in)	N/A	N/A	DWS Contrast?	N/A
N/A	Landing Slope (%)	N/A	N/A	DWS Length (in)	N/A
N/A	Landing X Slope (%)	N/A	N/A	DWS Full Width?	N/A
N/A	Landing Curb? (Y/N)	N/A	N/A	DWS Offset (in)	N/A
N/A	Shared Landing?	N/A			
N/A	Gutter Ponding?	N/A	N/A	Gutter Slope (%)	N/A
N/A	Gutter Lip Ht (in)	N/A	N/A	Gutter X Slope (%)	N/A
N/A	Painted X Walk1?	No	N/A	Painted X Walk2?	N/A
	X Walk 1 Direction	To SW		X Walk 2 Direction	N/A
N/A	X Walk 1 Width (in)	N/A	N/A	X Walk 2 Width (in)	N/A
	X Walk 1 Slope (%)	1.1		X Walk 2 Slope (%)	N/A
	X Walk 1 X Slope (%)	1.6		X Walk 2 X Slope (%)	N/A

N/A	Ramp inside XWalk1?	N/A	N/A	Ramp inside XWalk2?	N/A
	Road Slope (%)	N/A	N/A	Clear Space?	N/A
	Road X Slope (%)	N/A	N/A	Clear Space to XWalk (in)	N/A
N/A	Any Obstructions?	N/A	N/A	Storm Grate/Utility Hazard?	N/A
	Obstruction Type			Storm Grate/Utility Type	
		N/A			N/A
			Yes	Surface Condition? (G/P)	Good

Possible Solutions:

Remove & Replace Entire Ramp.

Total Cost: \$ 1850.00
