# Access Compliance Report

## Public Rights-of-Way

### (Curb Ramps)

| Intersection ID: 31442 | Main Street: LORDEN_AV | Cross Street: RIDING_HILL_AV | Location: NW |

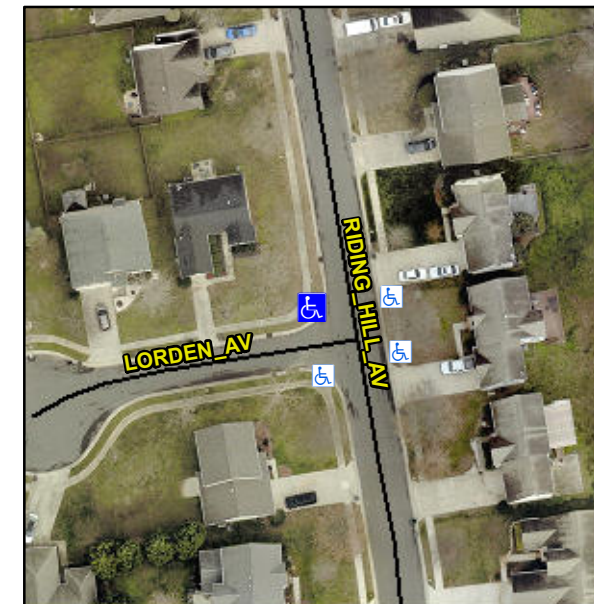
| ADA ID: 38FE512D0A55 | Ramp Type: BlendTrans1 | Initial Pass/Fail: Fail | Overall Compliance: No |
| | | | Severity Score: 33.75 |

**Not Found, R304.5.1, R304.5.3**

| Compliance | Description | Data | Compliance | Description | Data |
|---|---|---|---|---|---|
| No | Ramp Width (in) | 40.5 | No | BlendTrans XSlope (%) | 7.6 |

**Remove & Replace Curb Ramp With Two New Directional Ramps or Equivalent.**

Total Cost: \$ 3200.00
