# Access Compliance Report

## Public Rights-of-Way

### (Curb Ramps)

Intersection ID: 19012	Main Street: DEVERON_DR	Cross Street: RAMA_RD	Location: SW
ADA ID: 38FEA98F88B8	Ramp Type: PerpDiag	Initial Pass/Fail: Fail	Overall Compliance: No
Codes/Mitigation Info/Possible Solution		Field Measurements/Component Compliance	
Severity Score: 22.5

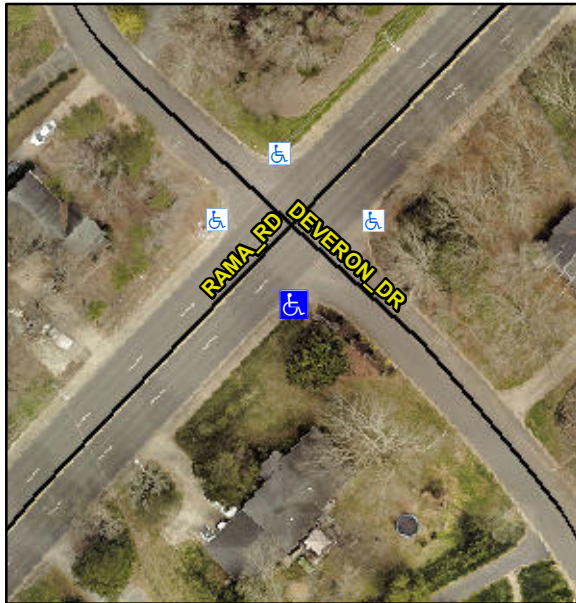
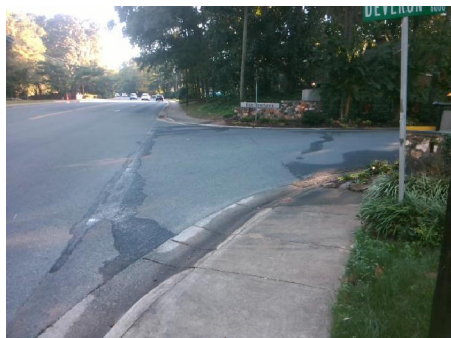
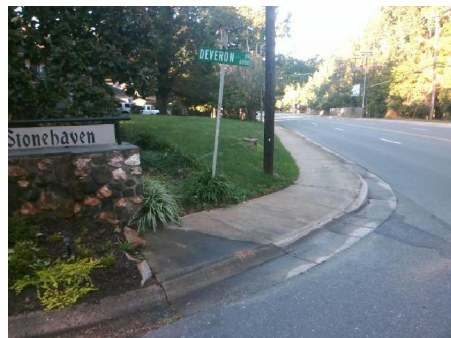
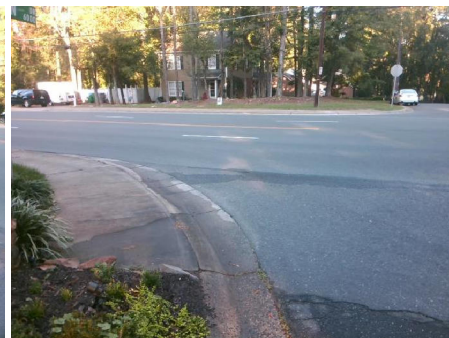
**Not Found, R304.5.1, R304.2.2, R304.5.3**

Compliance	Description	Data	Compliance	Description	Data
N/A	Ramp Length (in)	60.5	No	Ramp Slope (%)	9.2
No	Ramp Width (in)	36.5	No	Ramp XSlope (%)	3.5
N/A	Flare Type LT	N/A	N/A	Flare Type RT	N/A
N/A	Flare Slope LT (%)	N/A	N/A	Flare Slope RT (%)	N/A
N/A	Flare Traversable LT?	N/A	N/A	Flare Traversable RT?	N/A
N/A	Landing Length (in)	N/A	N/A	DWS Provided?	N/A
N/A	Landing Width (in)	N/A	N/A	DWS Contrast?	N/A
N/A	Landing Slope (%)	N/A	N/A	DWS Length (in)	N/A
N/A	Landing X Slope (%)	N/A	N/A	DWS Full Width?	N/A
N/A	Landing Curb? (Y/N)	N/A	N/A	DWS Offset (in)	N/A
N/A	Shared Landing?	N/A			
N/A	Gutter Ponding?	N/A	N/A	Gutter Slope (%)	N/A
N/A	Gutter Lip Ht (in)	N/A	N/A	Gutter X Slope (%)	N/A
N/A	Painted X Walk1?	No	N/A	Painted X Walk2?	No
	X Walk 1 Direction	To NE		X Walk 2 Direction	To NW
N/A	X Walk 1 Width (in)	N/A	N/A	X Walk 2 Width (in)	N/A
	X Walk 1 Slope (%)	3.1		X Walk 2 Slope (%)	4.1
	X Walk 1 X Slope (%)	0.0		X Walk 2 X Slope (%)	3.1

N/A	Ramp inside XWalk1?	N/A	N/A	Ramp inside XWalk2?	N/A
	Road Slope (%)	2.9	N/A	Clear Space?	N/A
	Road X Slope (%)	2.2	N/A	Clear Space to XWalk (in)	N/A
N/A	Any Obstructions?	N/A	N/A	Storm Grate/Utility Hazard?	N/A
	Obstruction Type			Storm Grate/Utility Type	
		N/A			N/A
			Yes	Surface Condition? (G/P)	Good

**Remove & Replace Curb Ramp With Two New Directional Ramps or Equivalent.**
