# Access Compliance Report

## Public Rights-of-Way

### (Curb Ramps)

Intersection ID: 20383	Main Street: CLEMATIS_DR	Cross Street: ARBOR_WAY	Location: NE
ADA ID: 3902CB7A3E78	Ramp Type: Directional1	Initial Pass/Fail: Fail	Overall Compliance: No
			Severity Score: 21.25

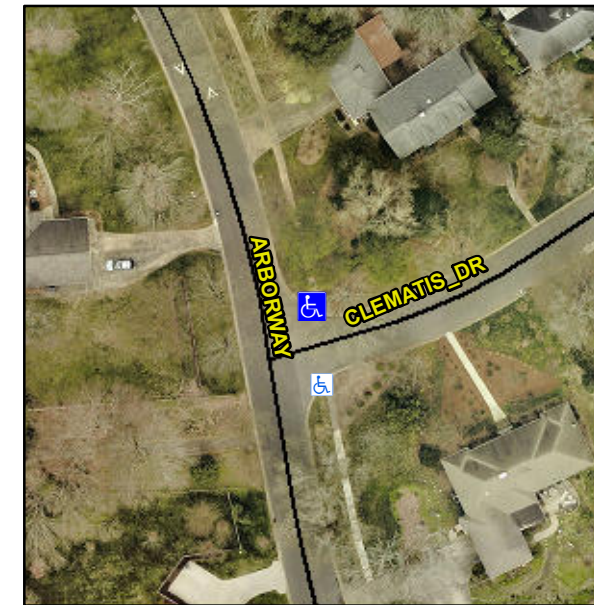
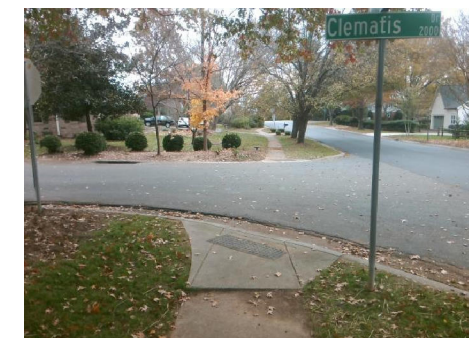
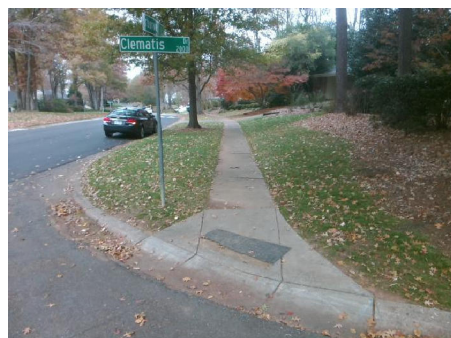
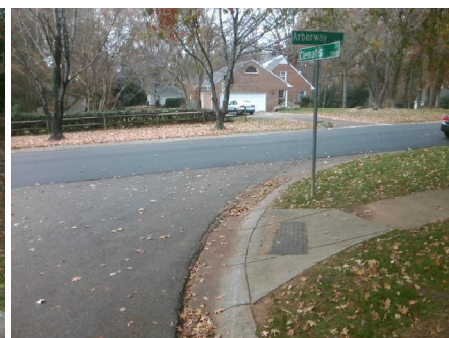
**R304.5.1, R304.5.3**

Compliance	Description	Data	Compliance	Description	Data
N/A	Ramp Length (in)	62.0	N/A	Grade Break?	N/A
No	Ramp Width (in)	41.0	N/A	Grade Break Slope (%)	0.0
Yes	Ramp Slope (%)	3.8	N/A	Grade Break XSlope (%)	0.0
No	Ramp XSlope (%)	5.1			
N/A	Flare Type LT	N/A	N/A	Flare Type RT	N/A
N/A	Flare Slope LT (%)	N/A	N/A	Flare Slope RT (%)	0.0
N/A	Flare Traversable LT?	N/A	N/A	Flare Traversable RT?	N/A
N/A	Landing Length (in)	0.0	N/A	DWS Provided?	N/A
N/A	Landing Width (in)	0.0	N/A	DWS Contrast?	N/A
N/A	Landing Slope (%)	0.0	N/A	DWS Length (in)	N/A
N/A	Landing X Slope (%)	0.0	N/A	DWS Full Width?	N/A
N/A	Landing Curb? (Y/N)	N/A	N/A	DWS Offset LT (in)	N/A
N/A	Shared Landing?	N/A	N/A	DWS Offset RT (in)	N/A
N/A	Gutter Ponding?	0.0	N/A	Gutter Slope (%)	N/A
N/A	Gutter Lip Ht (in)	0.0	N/A	Gutter X Slope (%)	N/A
N/A	Painted X Walk1?	No		Road Slope (%)	1.2
	X Walk 1 Direction	To S		Road X Slope (%)	4.3
	X Walk 1 Width (in)	N/A		Clear Space?	N/A

X Walk 1 Slope (%)	1.2	N/A	Clear Space to XWalk (in)	N/A
	X Walk 1 X Slope (%)	4.3	N/A	Storm Grate/Utility Hazard?	N/A
N/A	Ramp inside XWalk1?	N/A		Storm Grate/Utility Type	
N/A	Any Obstructions?	N/A			N/A
	Obstruction Type		Yes	Surface Condition? (G/P)	Good
			N/A	Curb Slope (%)	18.3

**Remove & Replace Entire Ramp.**
