Access Compliance Report Public Rights-of-Way (Curb Ramps)

Intersection ID: 46697 Main Street: GOLDFIELDS_DR Cross Street: COFFEEBERRY_LN Location: SE

ADA ID: 390C5654CFF6 Ramp Type: PerpDiag Initial Pass/Fail: Fail Overall Compliance: No Severity Score: 21.25

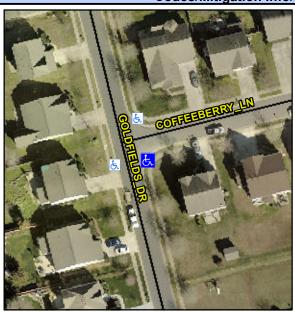
Not Found, R304.5.1, R304.2.2

Field Measurements/Component Compliance					
Compliance Description		Data	Comp	oliance Description	Data
N/	A Ramp Length (in)	46.0	No	Ramp Slope (%)	11.0
No	Ramp Width (in)	47.0	Yes	Ramp XSlope (%)	1.5
N/	A Flare Type LT	N/A	N/A	Flare Type RT	N/A
N/	A Flare Slope LT (%)	N/A	N/A	Flare Slope RT (%)	N/A
N/	A Flare Traversable LT?	N/A	N/A	Flare Traversable RT?	N/A
N/	A Landing Length (in)	N/A	N/A	DWS Provided?	N/A
N/	A Landing Width (in)	N/A	N/A	DWS Contrast?	N/A
N/	A Landing Slope (%)	N/A	N/A	DWS Length (in)	N/A
N/	A Landing X Slope (%)	N/A	N/A	DWS Full Width?	N/A
N/	A Landing Curb? (Y/N)	N/A	N/A	DWS Offset (in)	N/A
N/	A Shared Landing?	N/A			
N/	A Gutter Ponding?	N/A	N/A	Gutter Slope (%)	N/A
N/	A Gutter Lip Ht (in)	N/A	N/A	Gutter X Slope (%)	N/A
N/	A Painted X Walk1?	No	N/A	Painted X Walk2?	No
	X Walk 1 Direction	To N		X Walk 2 Direction	To W
N/	A X Walk 1 Width (in)	N/A	N/A	X Walk 2 Width (in)	N/A
	X Walk 1 Slope (%)	2.7		X Walk 2 Slope (%)	0.3

X Walk 1 X Slope (%)	0.5		X Walk 2 X Slope (%)	1.8
N/	A Ramp inside XWalk1?	N/A	N/A	Ramp inside XWalk2?	N/A
	Road Slope (%)	1.3	N/A	Clear Space?	N/A
	Road X Slope (%)	2.3	N/A	Clear Space to XWalk (in)	N/A
N/	Any Obstructions?	N/A	N/A	Storm Grate/Utility Hazard?	N/A
	Obstruction Type			Storm Grate/Utility Type	
		N/A			N/A
			Yes	Surface Condition? (G/P)	Good
Charles	705.

Remove & Replace Curb Ramp With Two New Directional Ramps or Equivalent.
