Access Compliance Report

Public Rights-of-Way

(Curb Ramps)

Intersection ID: 51794	Main Street: SUTTONVIEW_DR	Cross Street: BRADY_DR	Location: E
ADA ID: 3912C6F5C1B2	Ramp Type: PerpDiag	Initial Pass/Fail: Fail	Overall Compliance: No
Severity Score: 21.25			
Codes/Mitigation Info/Possible Solution		Field Measurements/Component Compliance

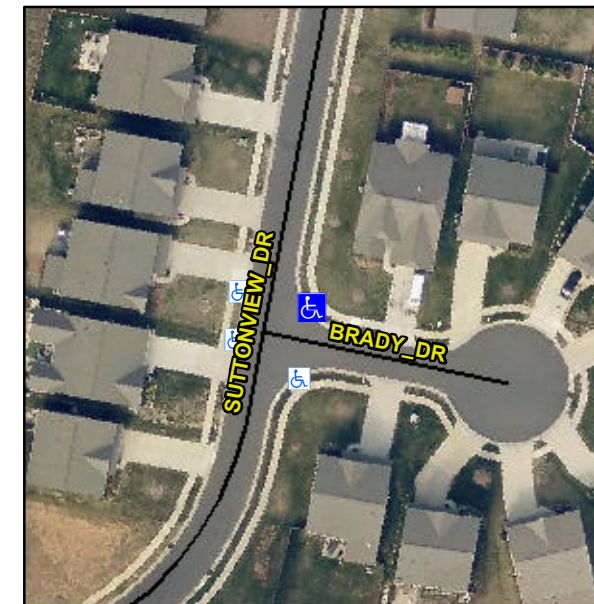
Not Found, R304.5.1, R304.5.3

Compliance	Description	Data	Compliance	Description	Data
N/A	Ramp Length (in)	47.5	Yes	Ramp Slope (%)	5.0
No	Ramp Width (in)	47.0	No	Ramp XSlope (%)	5.3
N/A	Flare Type LT	N/A	N/A	Flare Type RT	N/A
N/A	Flare Slope LT (%)	N/A	N/A	Flare Slope RT (%)	N/A
N/A	Flare Traversable LT?	N/A	N/A	Flare Traversable RT?	N/A
N/A	Landing Length (in)	N/A	N/A	DWS Provided?	N/A
N/A	Landing Width (in)	N/A	N/A	DWS Contrast?	N/A
N/A	Landing Slope (%)	N/A	N/A	DWS Length (in)	N/A
N/A	Landing X Slope (%)	N/A	N/A	DWS Full Width?	N/A
N/A	Landing Curb? (Y/N)	N/A	N/A	DWS Offset (in)	N/A
N/A	Shared Landing?	N/A			
N/A	Gutter Ponding?	N/A	N/A	Gutter Slope (%)	N/A
N/A	Gutter Lip Ht (in)	N/A	N/A	Gutter X Slope (%)	N/A
N/A	Painted X Walk1?	No	N/A	Painted X Walk2?	No
	X Walk 1 Direction	To NW		X Walk 2 Direction	To SW
N/A	X Walk 1 Width (in)	N/A	N/A	X Walk 2 Width (in)	N/A
	X Walk 1 Slope (%)	5.6		X Walk 2 Slope (%)	2.4
	X Walk 1 X Slope (%)	3.3		X Walk 2 X Slope (%)	6.9

N/A	Ramp inside XWalk1?	N/A	N/A	Ramp inside XWalk2?	N/A
	Road Slope (%)	6.1	N/A	Clear Space?	N/A
	Road X Slope (%)	3.4	N/A	Clear Space to XWalk (in)	N/A
N/A	Any Obstructions?	N/A	N/A	Storm Grate/Utility Hazard?	N/A
	Obstruction Type			Storm Grate/Utility Type	
		N/A			N/A
			Yes	Surface Condition? (G/P)	Good

Remove & Replace Curb Ramp With Two New Directional Ramps or Equivalent.
