# Access Compliance Report

## Public Rights-of-Way

| Intersection ID: 53288 | Main Street: PROSPERITY_CHURCH_RD | Cross Street: ROBERT_HELMS_RD | Location: SE |
| ADA ID: 3917CC15F458 | Ramp Type: BlendTrans1 | Initial Pass/Fail: Pass | Overall Compliance: No |

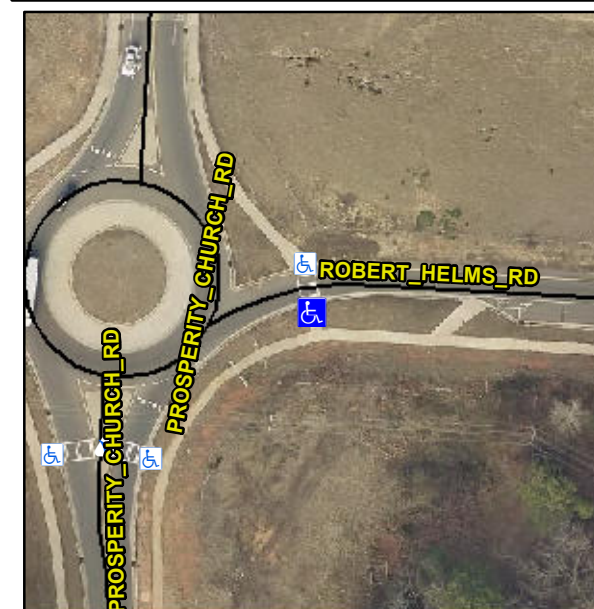
| Severity Score: 5 | | | |

| Compliance | Description | Data | Compliance | Description | Data |
|---|---|---|---|---|---|
| N/A | Landing Curb? (Y/N) | No | No | DWS Offset (in) | 3.0 |
| Yes | Gutter Ponding? | No | No | Gutter Slope (%) | 5.5 |

**Remove & Replace Detectable Warning System. Remove & Replace Gutter.**

**R305.2, R304.5.4**

Total Cost: \$ 1550.00
