Access Compliance Report

Public Rights-of-Way

(Curb Ramps)

Intersection ID: 23613	Main Street: PROVIDENCE_LN_WEST	Cross Street: REA_RD	Location: W
ADA ID: 391A544A36B9	Ramp Type: PerpDiag	Initial Pass/Fail: Fail	Overall Compliance: No
		Severity Score: 22.5

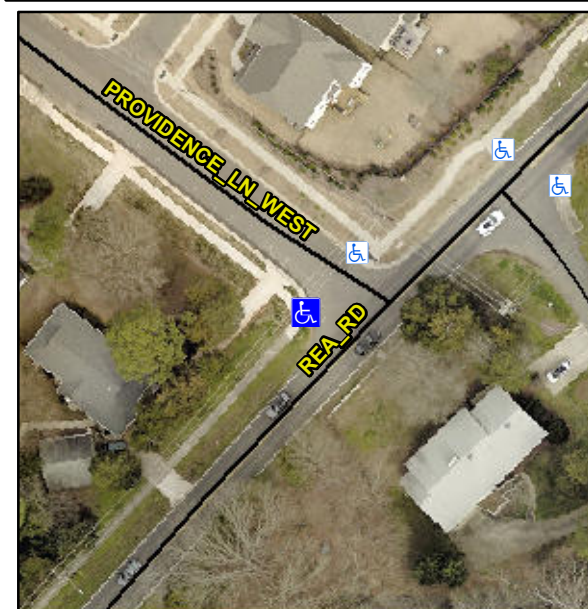
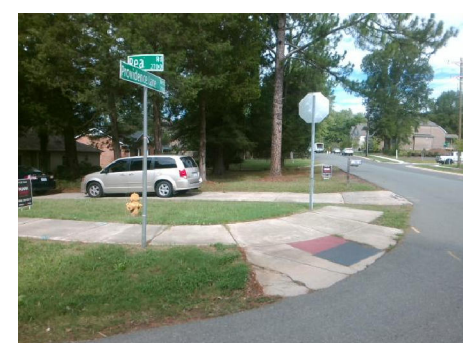
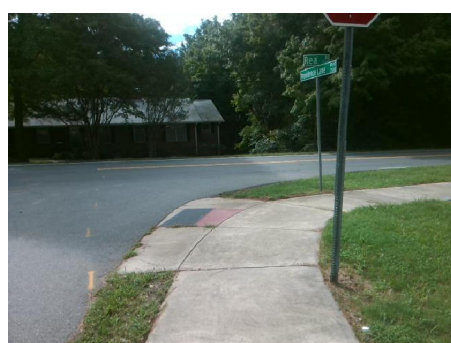
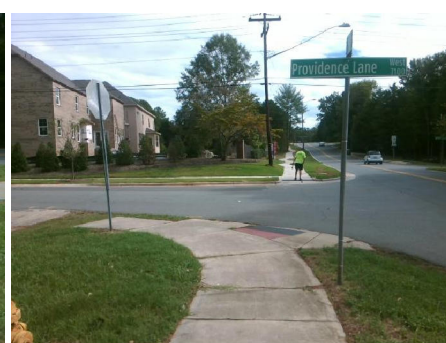
R304.5.1, R304.2.2, R304.5.3

Compliance	Description	Data	Compliance	Description	Data
N/A	Ramp Length (in)	44.0	No	Ramp Slope (%)	8.6
No	Ramp Width (in)	47.0	No	Ramp XSlope (%)	3.2
N/A	Flare Type LT	N/A	N/A	Flare Type RT	N/A
N/A	Flare Slope LT (%)	N/A	N/A	Flare Slope RT (%)	N/A
N/A	Flare Traversable LT?	N/A	N/A	Flare Traversable RT?	N/A
N/A	Landing Length (in)	N/A	N/A	DWS Provided?	N/A
N/A	Landing Width (in)	N/A	N/A	DWS Contrast?	N/A
N/A	Landing Slope (%)	N/A	N/A	DWS Length (in)	N/A
N/A	Landing X Slope (%)	N/A	N/A	DWS Full Width?	N/A
N/A	Landing Curb? (Y/N)	N/A	N/A	DWS Offset (in)	N/A
N/A	Shared Landing?	N/A			
N/A	Gutter Ponding?	N/A	N/A	Gutter Slope (%)	N/A
N/A	Gutter Lip Ht (in)	N/A	N/A	Gutter X Slope (%)	N/A
N/A	Painted X Walk1?	No	N/A	Painted X Walk2?	No
	X Walk 1 Direction	To SE		X Walk 2 Direction	To NE
N/A	X Walk 1 Width (in)	N/A	N/A	X Walk 2 Width (in)	N/A
	X Walk 1 Slope (%)	3.3		X Walk 2 Slope (%)	3.5
	X Walk 1 X Slope (%)	4.4		X Walk 2 X Slope (%)	2.3

N/A	Ramp inside XWalk1?	N/A	N/A	Ramp inside XWalk2?	N/A
	Road Slope (%)	3.0	N/A	Clear Space?	N/A
	Road X Slope (%)	2.3	N/A	Clear Space to XWalk (in)	N/A
N/A	Any Obstructions?	N/A	N/A	Storm Grate/Utility Hazard?	N/A
	Obstruction Type			Storm Grate/Utility Type	
		N/A			N/A
			Yes	Surface Condition? (G/P)	Good

Remove & Replace Curb Ramp With Two New Directional Ramps or Equivalent.
