# Access Compliance Report

## Public Rights-of-Way

### (Curb Ramps)

Intersection ID: 43670	Main Street: S_TRYON_ST	Cross Street: CORSICA_FOREST_DR	Location: NW
ADA ID: 3920D8F8A1AC	Ramp Type: Perp	Initial Pass/Fail: Fail	Overall Compliance: No
Severity Score: 26.25			
Codes/Mitigation Info/Possible Solution		Field Measurements/Component Compliance

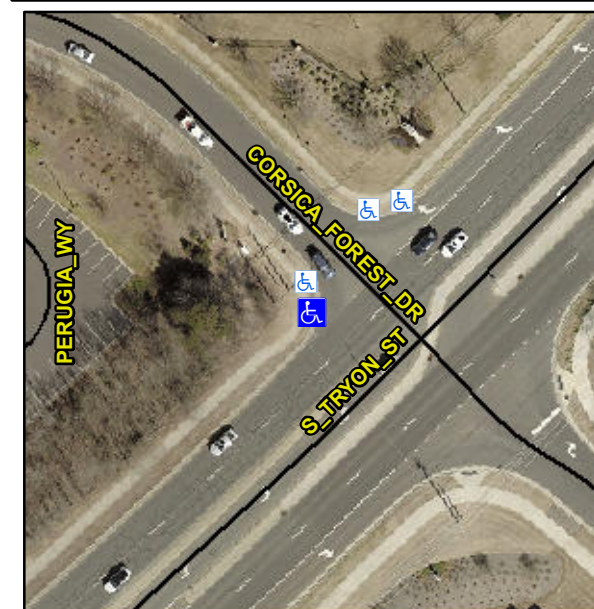
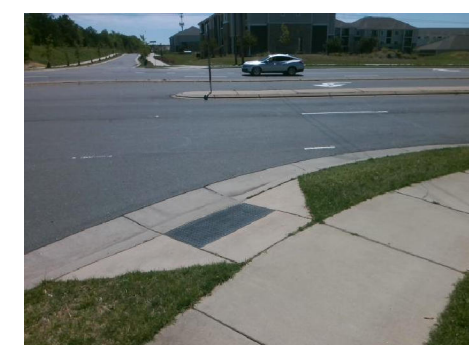
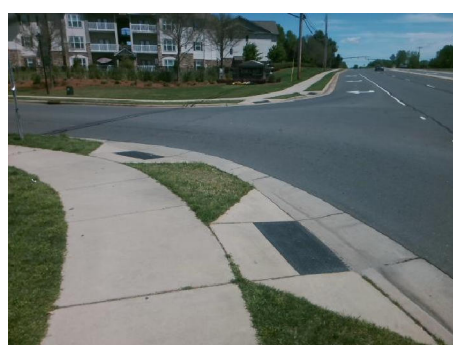
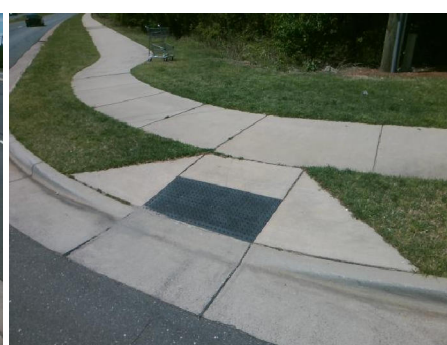
Compliance	Description	Data	Compliance	Description	Data
N/A	Ramp Length (in)	48.0	No	Ramp Slope (%)	12.9
Yes	Ramp Width (in)	48.0	No	Ramp XSlope (%)	2.6
N/A	Flare Type LT	N/A	N/A	Flare Type RT	N/A
N/A	Flare Slope LT (%)	N/A	N/A	Flare Slope RT (%)	N/A
N/A	Flare Traversable LT?	N/A	N/A	Flare Traversable RT?	N/A
N/A	Landing Length (in)	N/A	N/A	DWS Provided?	N/A
N/A	Landing Width (in)	N/A	N/A	DWS Contrast?	N/A
N/A	Landing Slope (%)	N/A	N/A	DWS Length (in)	N/A
N/A	Landing X Slope (%)	N/A	N/A	DWS Full Width?	N/A
N/A	Landing Curb? (Y/N)	N/A	N/A	DWS Offset (in)	N/A
N/A	Shared Landing?	N/A			
N/A	Gutter Ponding?	N/A	N/A	Gutter Slope (%)	N/A
N/A	Gutter Lip Ht (in)	N/A	N/A	Gutter X Slope (%)	N/A
N/A	Painted X Walk1?	No	N/A	Painted X Walk2?	N/A
	X Walk 1 Direction	To SE		X Walk 2 Direction	N/A
N/A	X Walk 1 Width (in)	N/A	N/A	X Walk 2 Width (in)	N/A
	X Walk 1 Slope (%)	0.4		X Walk 2 Slope (%)	N/A
	X Walk 1 X Slope (%)	2.3		X Walk 2 X Slope (%)	N/A

N/A	Ramp inside XWalk1?	N/A	N/A	Ramp inside XWalk2?	N/A
	Road Slope (%)	N/A	N/A	Clear Space?	N/A
	Road X Slope (%)	N/A	N/A	Clear Space to XWalk (in)	N/A
N/A	Any Obstructions?	N/A	N/A	Storm Grate/Utility Hazard?	N/A
	Obstruction Type			Storm Grate/Utility Type	
		N/A			N/A
			Yes	Surface Condition? (G/P)	Good

**Remove & Replace Entire Ramp.**
