# Access Compliance Report

## Public Rights-of-Way

| Intersection ID: 10976 | Main Street: COLEBROOK_RD | Cross Street: MILTON_RD | Location: W |
| ADA ID: 39246A136C7D | Ramp Type: ParaDiag | Initial Pass/Fail: Pass | Overall Compliance: No |

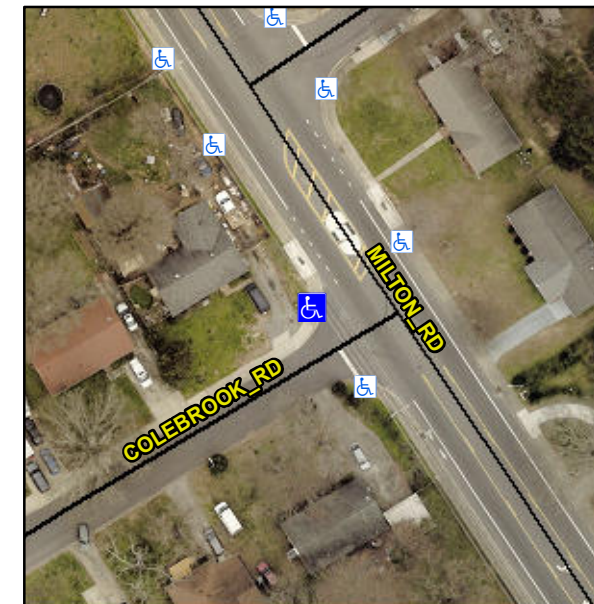
**R304.2.1, R304.2.2-Perp, R304.3.2-Para**

| Compliance | Description | Data | Compliance | Description | Data |
|---|---|---|---|---|---|
| No | Landing Width (in) | 47.0 | Yes | DWS Contrast? | Yes |
| No | Landing Slope (%) | 2.5 | Yes | DWS Length (in) | 24.0 |

**Remove & Replace Landing.**
