Access Compliance Report

Public Rights-of-Way

(Curb Ramps)

Intersection ID: 16911	Main Street: IDLEWILD_RD	Cross Street: SPRINGFIELD_DR	Location: NE
ADA ID: 392664369621	Ramp Type: PerpDiag	Initial Pass/Fail: Fail	Overall Compliance: No
		Severity Score: 13.75

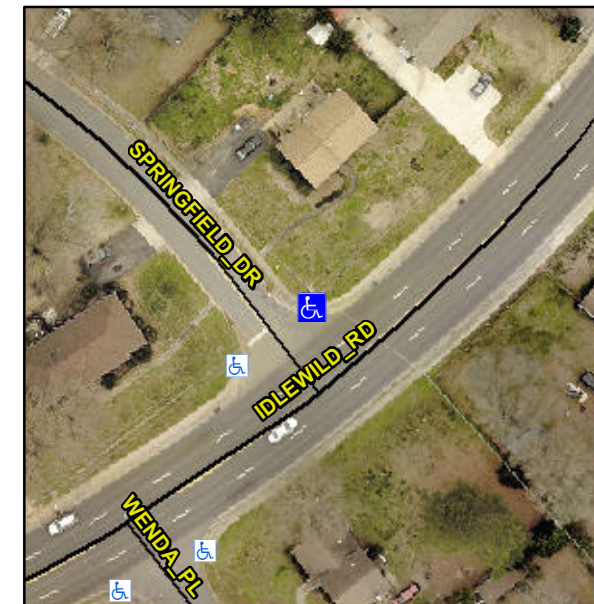
Not Found, R304.2.2, R304.5.3

Compliance	Description	Data	Compliance	Description	Data
N/A	Ramp Length (in)	60.0	No	Ramp Slope (%)	9.8
Yes	Ramp Width (in)	48.0	No	Ramp XSlope (%)	2.1
N/A	Flare Type LT	N/A	N/A	Flare Type RT	N/A
N/A	Flare Slope LT (%)	N/A	N/A	Flare Slope RT (%)	N/A
N/A	Flare Traversable LT?	N/A	N/A	Flare Traversable RT?	N/A
N/A	Landing Length (in)	N/A	N/A	DWS Provided?	N/A
N/A	Landing Width (in)	N/A	N/A	DWS Contrast?	N/A
N/A	Landing Slope (%)	N/A	N/A	DWS Length (in)	N/A
N/A	Landing X Slope (%)	N/A	N/A	DWS Full Width?	N/A
N/A	Landing Curb? (Y/N)	N/A	N/A	DWS Offset (in)	N/A
N/A	Shared Landing?	N/A			
N/A	Gutter Ponding?	N/A	N/A	Gutter Slope (%)	N/A
N/A	Gutter Lip Ht (in)	N/A	N/A	Gutter X Slope (%)	N/A
N/A	Painted X Walk1?	No	N/A	Painted X Walk2?	No
	X Walk 1 Direction	To SW		X Walk 2 Direction	To SE
N/A	X Walk 1 Width (in)	N/A	N/A	X Walk 2 Width (in)	N/A
	X Walk 1 Slope (%)	1.4		X Walk 2 Slope (%)	3.3
	X Walk 1 X Slope (%)	2.7		X Walk 2 X Slope (%)	2.0

N/A	Ramp inside XWalk1?	N/A	N/A	Ramp inside XWalk2?	N/A
	Road Slope (%)	2.0	N/A	Clear Space?	N/A
	Road X Slope (%)	4.2	N/A	Clear Space to XWalk (in)	N/A
N/A	Any Obstructions?	N/A	N/A	Storm Grate/Utility Hazard?	N/A
	Obstruction Type			Storm Grate/Utility Type	
		N/A			N/A
			Yes	Surface Condition? (G/P)	Good

Remove & Replace Curb Ramp With Two New Directional Ramps or Equivalent.
