Access Compliance Report

Public Rights-of-Way

(Curb Ramps)

Intersection ID: 13891	Main Street: CLEMENT_AV	Cross Street: E_7TH_ST	Location:	N
ADA ID: 3938B6C87D7E	Ramp Type: Perp	Initial Pass/Fail: Fail	Overall Compliance: No	Severity Score: 1.25
Codes/Mitigation Info/Possible Solution		Field Measurements/Component Compliance

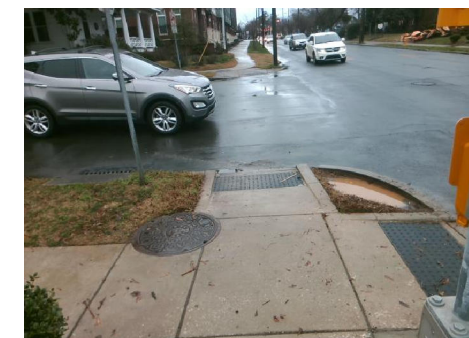
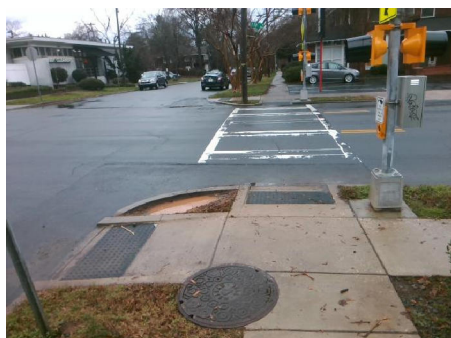
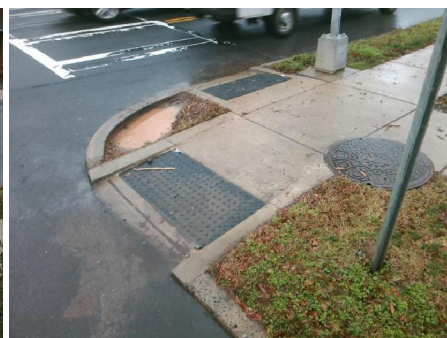
Compliance	Description	Data	Compliance	Description	Data
N/A	Ramp Length (in)	61.0	Yes	Ramp Slope (%)	6.3
Yes	Ramp Width (in)	49.0	No	Ramp XSlope (%)	3.8
N/A	Flare Type LT	N/A	N/A	Flare Type RT	N/A
N/A	Flare Slope LT (%)	N/A	N/A	Flare Slope RT (%)	N/A
N/A	Flare Traversable LT?	N/A	N/A	Flare Traversable RT?	N/A
N/A	Landing Length (in)	N/A	N/A	DWS Provided?	N/A
N/A	Landing Width (in)	N/A	N/A	DWS Contrast?	N/A
N/A	Landing Slope (%)	N/A	N/A	DWS Length (in)	N/A
N/A	Landing X Slope (%)	N/A	N/A	DWS Full Width?	N/A
N/A	Landing Curb? (Y/N)	N/A	N/A	DWS Offset (in)	N/A
N/A	Shared Landing?	N/A			
N/A	Gutter Ponding?	N/A	N/A	Gutter Slope (%)	N/A
N/A	Gutter Lip Ht (in)	N/A	N/A	Gutter X Slope (%)	N/A
N/A	Painted X Walk1?	No	N/A	Painted X Walk2?	N/A
	X Walk 1 Direction	To SE		X Walk 2 Direction	N/A
N/A	X Walk 1 Width (in)	N/A	N/A	X Walk 2 Width (in)	N/A
	X Walk 1 Slope (%)	6.3		X Walk 2 Slope (%)	N/A
	X Walk 1 X Slope (%)	1.7		X Walk 2 X Slope (%)	N/A

N/A	Ramp inside XWalk1?	N/A	N/A	Ramp inside XWalk2?	N/A
	Road Slope (%)	N/A	N/A	Clear Space?	N/A
	Road X Slope (%)	N/A	N/A	Clear Space to XWalk (in)	N/A
N/A	Any Obstructions?	N/A	N/A	Storm Grate/Utility Hazard?	N/A
	Obstruction Type			Storm Grate/Utility Type	
		N/A			N/A
			Yes	Surface Condition? (G/P)	Good

Possible Solutions:

Remove & Replace Entire Ramp.

R304.5.3
