Access Compliance Report

Public Rights-of-Way

(Curb Ramps)

| Intersection ID: 10024504 | Main Street: CRUMP_RD | Cross Street: N/A | Location: SW |

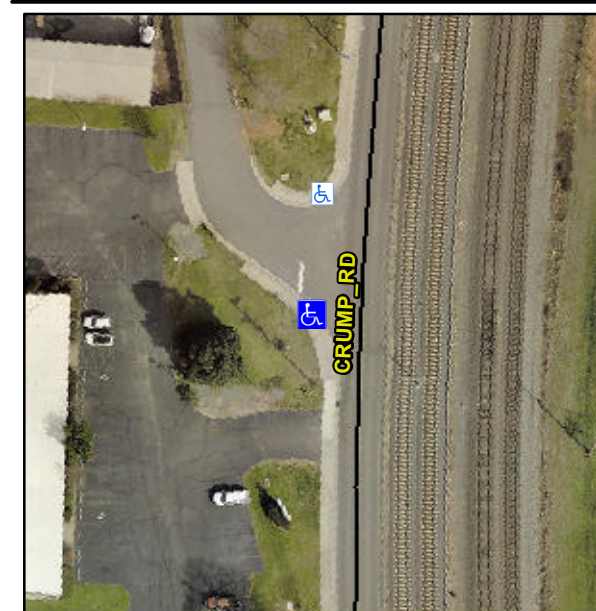
| ADA ID: 394988EA66C9 | Ramp Type: Perp | Initial Pass/Fail: Fail | Overall Compliance: No |
| Severity Score: 21.25 | | | |

Not Found, R304.5.1, R304.2.2

| Compliance | Description | Data | Compliance | Description | Data |
|---|---|---|---|---|---|
| N/A | Ramp Length (in) | 58.0 | No | Ramp Slope (%) | 8.8 |
| No | Ramp Width (in) | 47.0 | Yes | Ramp XSlope (%) | 1.8 |

Possible Solutions:

Remove & Replace Entire Ramp.
