Access Compliance Report Public Rights-of-Way (Curb Ramps)

Intersection ID: 52591 Main Street: INNOVATION_DR Cross Street: NOBLES_AV Location: NW

ADA ID: 394B57B42F3D Ramp Type: Perp Initial Pass/Fail: Fail Overall Compliance: No Severity Score: 12.5

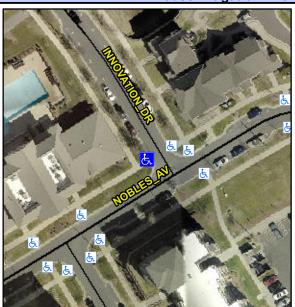
| Comp | liance Description | Data | | | Description | Data |
|---|---|---|---|---|---|---|
| N/A | Ramp Length (in) | 78.0 | Yes | Ramp | Slope (%) | 5.5 |
| Yes | Ramp Width (in) | 72.0 | No | Ram | XSlope (%) | 5.5 |

Total Cost:

1850.00
