Access Compliance Report

Public Rights-of-Way

(Curb Ramps)

Intersection ID: 10040846	Main Street: WAKEFIELD_DR	Cross Street: N/A	Location: S
ADA ID: 394CB7E75316	Ramp Type: PerpDiag	Initial Pass/Fail: Fail	Overall Compliance: No
Severity Score: 10			
Codes/Mitigation Info/Possible Solution		Field Measurements/Component Compliance

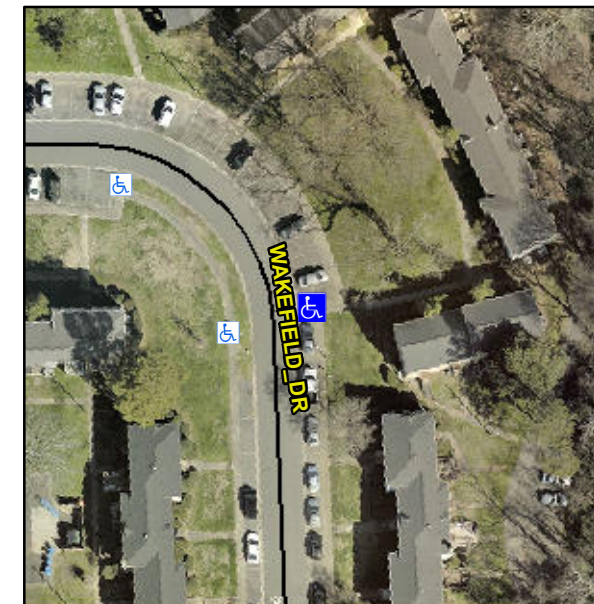
Not Found, R304.5.1, R304.5.3

Compliance	Description	Data	Compliance	Description	Data
N/A	Ramp Length (in)	38.0	Yes	Ramp Slope (%)	6.0
No	Ramp Width (in)	47.0	No	Ramp XSlope (%)	4.1
N/A	Flare Type LT	N/A	N/A	Flare Type RT	N/A
N/A	Flare Slope LT (%)	N/A	N/A	Flare Slope RT (%)	N/A
N/A	Flare Traversable LT?	N/A	N/A	Flare Traversable RT?	N/A
N/A	Landing Length (in)	N/A	N/A	DWS Provided?	N/A
N/A	Landing Width (in)	N/A	N/A	DWS Contrast?	N/A
N/A	Landing Slope (%)	N/A	N/A	DWS Length (in)	N/A
N/A	Landing X Slope (%)	N/A	N/A	DWS Full Width?	N/A
N/A	Landing Curb? (Y/N)	N/A	N/A	DWS Offset (in)	N/A
N/A	Shared Landing?	N/A			
N/A	Gutter Ponding?	N/A	N/A	Gutter Slope (%)	N/A
N/A	Gutter Lip Ht (in)	N/A	N/A	Gutter X Slope (%)	N/A
N/A	Painted X Walk1?	No	N/A	Painted X Walk2?	No
	X Walk 1 Direction	To N		X Walk 2 Direction	To W
N/A	X Walk 1 Width (in)	N/A	N/A	X Walk 2 Width (in)	N/A
	X Walk 1 Slope (%)	1.1		X Walk 2 Slope (%)	4.0
	X Walk 1 X Slope (%)	2.1		X Walk 2 X Slope (%)	0.6

N/A	Ramp inside XWalk1?	N/A	N/A	Ramp inside XWalk2?	N/A
	Road Slope (%)	2.3	N/A	Clear Space?	N/A
	Road X Slope (%)	3.0	N/A	Clear Space to XWalk (in)	N/A
N/A	Any Obstructions?	N/A	N/A	Storm Grate/Utility Hazard?	N/A
	Obstruction Type			Storm Grate/Utility Type	
		N/A			N/A
			Yes	Surface Condition? (G/P)	Good

Remove & Replace Curb Ramp With Two New Directional Ramps or Equivalent.
