# Access Compliance Report

## Public Rights-of-Way

### (Curb Ramps)

Intersection ID: 8863	Main Street: CARDIGAN_AV	Cross Street: EASTBROOK_RD	Location: SE
ADA ID: 3951ADB06D1F	Ramp Type: BlendTrans1	Initial Pass/Fail: Fail	Overall Compliance: No
Severity Score: 1.25			
Codes/Mitigation Info/Possible Solution		Field Measurements/Component Compliance

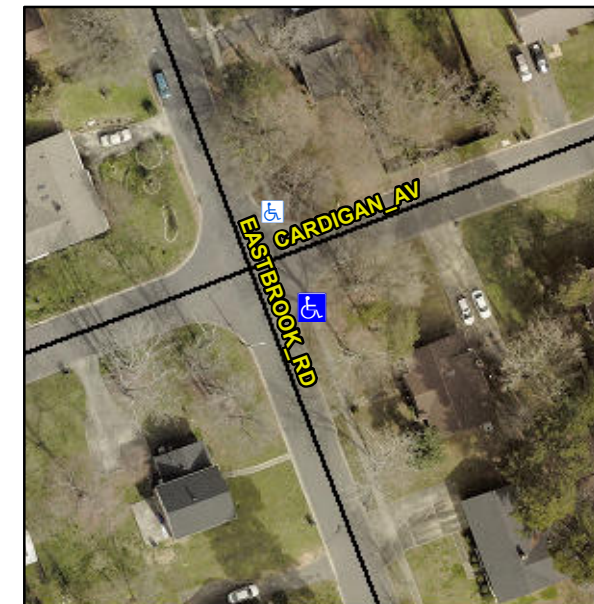
**Not Found, R304.5.3**

Compliance	Description	Data	Compliance	Description	Data
N/A	Ramp Length (in)	43.0	Yes	BlendTrans Slope (%)	4.6
Yes	Ramp Width (in)	48.0	No	BlendTrans XSlope (%)	2.8
N/A	Flare Type LT	N/A	N/A	Flare Type RT	N/A
N/A	Flare Slope LT (%)	N/A	N/A	Flare Slope RT (%)	N/A
N/A	Flare Traversable LT?	N/A	N/A	Flare Traversable RT?	N/A
N/A	Landing Length (in)	N/A	N/A	DWS Provided?	N/A
N/A	Landing Width (in)	N/A	N/A	DWS Contrast?	N/A
N/A	Landing Slope (%)	N/A	N/A	DWS Length (in)	N/A
N/A	Landing X Slope (%)	N/A	N/A	DWS Full Width?	N/A
N/A	Landing Curb? (Y/N)	N/A	N/A	DWS Offset (in)	N/A
N/A	Shared Landing?	N/A			
N/A	Gutter Ponding?	N/A	N/A	Gutter Slope (%)	N/A
N/A	Gutter Lip Ht (in)	N/A	N/A	Gutter X Slope (%)	N/A
N/A	Painted X Walk1?	No	N/A	Painted X Walk2?	N/A
	X Walk 1 Direction	To N		X Walk 2 Direction	N/A
	X Walk 1 Width (in)	N/A		X Walk 2 Width (in)	N/A
	X Walk 1 Slope (%)	2.5		X Walk 2 Slope (%)	N/A
	X Walk 1 X Slope (%)	0.4		X Walk 2 X Slope (%)	N/A

N/A	Ramp inside XWalk1?	N/A	N/A	Ramp inside XWalk2?	N/A
	Road Slope (%)	0.4		Clear Space?	N/A
	Road X Slope (%)	2.5	N/A	Clear Space to XWalk (in)	N/A
N/A	Any Obstructions?	N/A	N/A	Storm Grate/Utility Hazard?	N/A
	Obstruction Type			Storm Grate/Utility Type	
		N/A			N/A
			Yes	Surface Condition? (G/P)	Good
			No	Curb Slope (%)	12.6

**Remove & Replace Curb Ramp With Two New Directional Ramps or Equivalent.**
