Access Compliance Report

Public Rights-of-Way

(Curb Ramps)

Intersection ID: 10035097	Main Street: PROVIDENCE_RD	Cross Street: N/A	Location: NE
ADA ID: 395EAC7E7AB8	Ramp Type: BlendTrans1	Initial Pass/Fail: Fail	Overall Compliance: No
Codes/Mitigation Info/Possible Solution		Field Measurements/Component Compliance	
Severity Score: 1.25

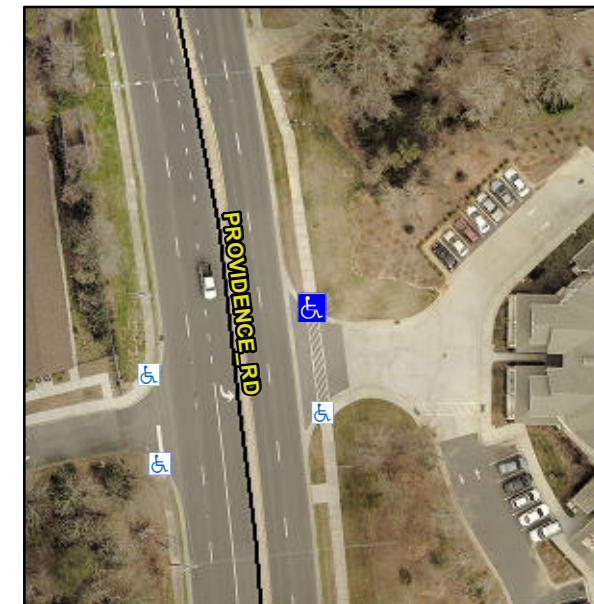
Compliance	Description	Data	Compliance	Description	Data
N/A	Ramp Length (in)	47.0	Yes	BlendTrans Slope (%)	1.0
Yes	Ramp Width (in)	72.0	No	BlendTrans XSlope (%)	2.9
N/A	Flare Type LT	N/A	N/A	Flare Type RT	N/A
N/A	Flare Slope LT (%)	N/A	N/A	Flare Slope RT (%)	N/A
N/A	Flare Traversable LT?	N/A	N/A	Flare Traversable RT?	N/A
N/A	Landing Length (in)	N/A	N/A	DWS Provided?	N/A
N/A	Landing Width (in)	N/A	N/A	DWS Contrast?	N/A
N/A	Landing Slope (%)	N/A	N/A	DWS Length (in)	N/A
N/A	Landing X Slope (%)	N/A	N/A	DWS Full Width?	N/A
N/A	Landing Curb? (Y/N)	N/A	N/A	DWS Offset (in)	N/A
N/A	Shared Landing?	N/A			
N/A	Gutter Ponding?	N/A	N/A	Gutter Slope (%)	N/A
N/A	Gutter Lip Ht (in)	N/A	N/A	Gutter X Slope (%)	N/A
N/A	Painted X Walk1?	Yes	N/A	Painted X Walk2?	N/A
	X Walk 1 Direction	To S		X Walk 2 Direction	N/A
	X Walk 1 Width (in)	66.0		X Walk 2 Width (in)	N/A
	X Walk 1 Slope (%)	2.5		X Walk 2 Slope (%)	N/A
	X Walk 1 X Slope (%)	1.3		X Walk 2 X Slope (%)	N/A

N/A	Ramp inside XWalk1?	Yes	N/A	Ramp inside XWalk2?	N/A
	Road Slope (%)	1.3		Clear Space?	N/A
	Road X Slope (%)	2.5	N/A	Clear Space to XWalk (in)	N/A
N/A	Any Obstructions?	N/A	N/A	Storm Grate/Utility Hazard?	N/A
	Obstruction Type			Storm Grate/Utility Type	
		N/A			N/A
			Yes	Surface Condition? (G/P)	Good
			No	Curb Slope (%)	6.5

Possible Solutions:

Remove & Replace Curb Ramp With Two New Directional Ramps or Equivalent.
