# Access Compliance Report

## Public Rights-of-Way

| Intersection ID: 31497 | Main Street: JORDANS_POND_LN | Cross Street: KONSLEDR | Location: NE |
| ADA ID: 396E12FDF102 | Ramp Type: PerpDiag | Initial Pass/Fail: Pass | Overall Compliance: No |

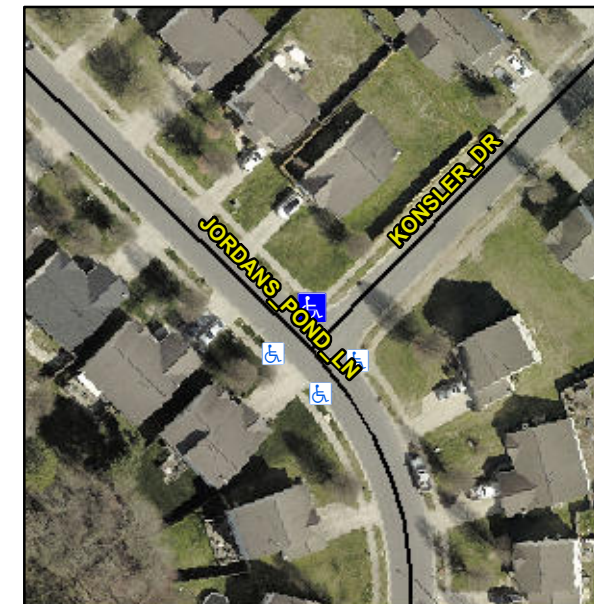
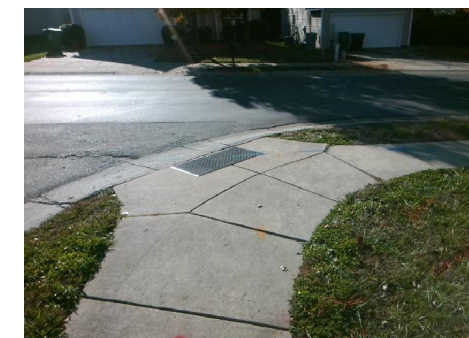
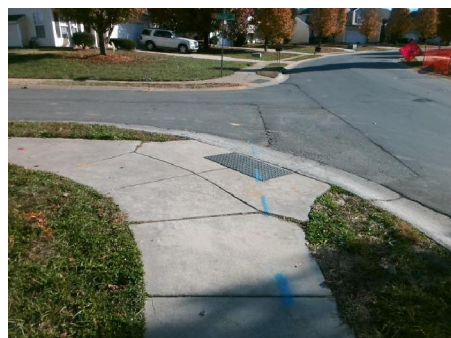
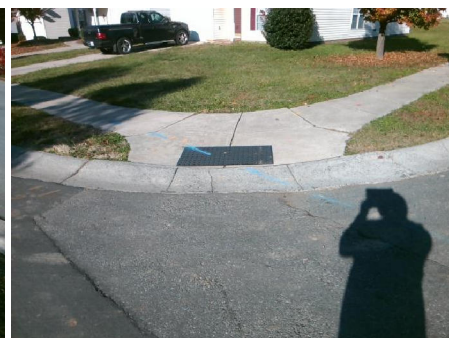
**Not Found, R304.5.3, R304.2.1, R302.7.2**

| Compliance | Description | Data | Compliance | Description | Data |
|---|---|---|---|---|---|
| Yes | Ramp Width (in) | 53.0 | No | Ramp XSlope (%) | 4.0 |
| No | Landing Length (in) | 46.0 | Yes | DWS Provided? | Yes |
| No | Landing X Slope (%) | 3.8 | Yes | DWS Full Width? | Yes |
| No | Gutter Lip Ht (in) | 0.5 | No | Gutter X Slope (%) | 3.1 |

**Remove & Replace Curb Ramp With Two New Directional Ramps or Equivalent. Remove & Replace Gutter.**
