Access Compliance Report Public Rights-of-Way (Curb Ramps)

Intersection ID: 10014838 Main Street: THE PLAZA **Cross Street: N/A** Location: SW

ADA ID: 397CA2B78E17 Ramp Type: PerpDiag Initial Pass/Fail: Pass **Overall Compliance: No Severity Score:**

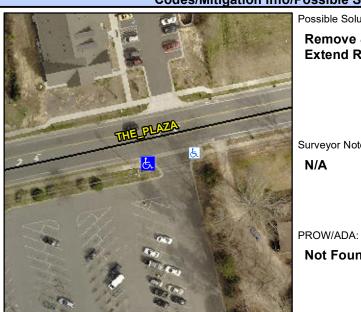
Field Measurements/Component Compliance					
Compliance Description		Data	Compliance Description		Data
N/A	Ramp Length (in)	25.0	Yes	Ramp Slope (%)	5.7
Yes	Ramp Width (in)	48.0	Yes	Ramp XSlope (%)	0.3
N/A	Flare Type LT	Sloped	N/A	Flare Type RT	N/A
N/A	Flare Slope LT (%)	6.1	N/A	Flare Slope RT (%)	5.1
N/A	Flare Traversable LT?	No	N/A	Flare Traversable RT?	No
Yes	Landing Length (in)	61.0	Yes	DWS Provided?	Yes
Yes	Landing Width (in)	48.0	Yes	DWS Contrast?	Yes
Yes	Landing Slope (%)	1.3	Yes	DWS Length (in)	24.0
Yes	Landing X Slope (%)	1.8	Yes	DWS Full Width?	Yes
N/A	Landing Curb? (Y/N)	No	Yes	DWS Offset (in)	1.0
N/A	Shared Landing?	No			
Yes	Gutter Ponding?	No	Yes	Gutter Slope (%)	0.1
Yes	Gutter Lip Ht (in)	0.0	Yes	Gutter X Slope (%)	0.4
N/A	Painted X Walk1?	No	N/A	Painted X Walk2?	No
	X Walk 1 Direction	То Е		X Walk 2 Direction	To N
N/A	X Walk 1 Width (in)	N/A	N/A	X Walk 2 Width (in)	N/A
	X Walk 1 Slope (%)	1.4		X Walk 2 Slope (%)	0.2

X Walk 1 X Slope (%)	0.3		X Walk 2 X Slope (%)	1.1
N/A	Ramp inside XWalk1?	N/A	N/A	Ramp inside XWalk2?	N/A
	Road Slope (%)	0.7	N/A	Clear Space?	Yes
	Road X Slope (%)	1.3	N/A	Clear Space to XWalk (in)	N/A
Yes	Any Obstructions?	No	Yes	Storm Grate/Utility Hazard?	No
	Obstruction Type			Storm Grate/Utility Type	
		N/A			N/A
			Yes	Surface Condition? (G/P)	Good
The state of

Street 1 Name **ENTRANCE** Stop Condition-Street 2 None Street 2 Name **THE PLAZA** Stop Condition-Street 1 None Possible Solutions: Remove & Replace Curb Slope and Extend Ramp. Surveyor Notes: **Not Found**

Total Cost: 2000.00
