Access Compliance Report

Public Rights-of-Way

(Curb Ramps)

Intersection ID: 10023686	Main Street: COCA-COLA_PLAZA	Cross Street: N/A	Location: SW
ADA ID: 398E68491899	Ramp Type: Directional1	Initial Pass/Fail: Fail	Overall Compliance: No
			Severity Score: 21.25

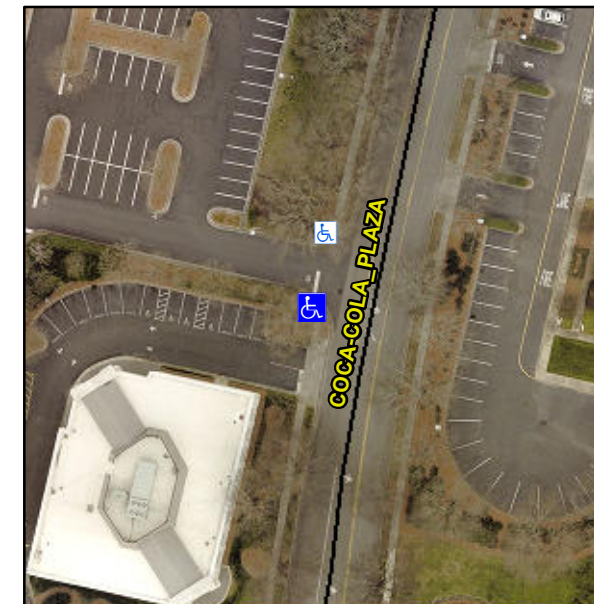
Compliance	Description	Data	Compliance	Description	Data
N/A	Ramp Length (in)	59.0	N/A	Grade Break?	N/A
No	Ramp Width (in)	47.0	N/A	Grade Break Slope (%)	0.0
Yes	Ramp Slope (%)	5.1	N/A	Grade Break XSlope (%)	0.0
No	Ramp XSlope (%)	5.8			
N/A	Flare Type LT	N/A	N/A	Flare Type RT	N/A
N/A	Flare Slope LT (%)	N/A	N/A	Flare Slope RT (%)	0.0
N/A	Flare Traversable LT?	N/A	N/A	Flare Traversable RT?	N/A
N/A	Landing Length (in)	0.0	N/A	DWS Provided?	N/A
N/A	Landing Width (in)	0.0	N/A	DWS Contrast?	N/A
N/A	Landing Slope (%)	0.0	N/A	DWS Length (in)	N/A
N/A	Landing X Slope (%)	0.0	N/A	DWS Full Width?	N/A
N/A	Landing Curb? (Y/N)	N/A	N/A	DWS Offset LT (in)	N/A
N/A	Shared Landing?	N/A	N/A	DWS Offset RT (in)	N/A
N/A	Gutter Ponding?	0.0	N/A	Gutter Slope (%)	N/A
N/A	Gutter Lip Ht (in)	0.0	N/A	Gutter X Slope (%)	N/A
N/A	Painted X Walk1?	No		Road Slope (%)	5.5
	X Walk 1 Direction	To N		Road X Slope (%)	3.9
	X Walk 1 Width (in)	N/A		Clear Space?	N/A

X Walk 1 Slope (%)	5.5	N/A	Clear Space to XWalk (in)	N/A
	X Walk 1 X Slope (%)	3.9	N/A	Storm Grate/Utility Hazard?	N/A
N/A	Ramp inside XWalk1?	N/A		Storm Grate/Utility Type	
N/A	Any Obstructions?	N/A			N/A
	Obstruction Type		Yes	Surface Condition? (G/P)	Good
			N/A	Curb Slope (%)	23.4

Remove & Replace Entire Ramp.
