Access Compliance Report Public Rights-of-Way (Curb Ramps)

Intersection ID: 10036981 Main Street: S_TRYON_ST					N/A	Location:	SE		
ADA ID: 3991CFE662B6	Ramp Type: PerpDiag			Initial Pass/Fail: Fail Overall Compliance: No					
Codes/Mitigation Info/Possible Solution				Field Measurements/Component Compliance					
Possible Solutions:								liance Description	Data
		Remove & Replace Curb Ramp Wit Two New Directional Ramps or Equivalent.	\ \ /;+b	N/A	Ramp Length (in)	85.0	1	Ramp Slope (%)	8.4
			VVILII	No	Ramp Width (in)	47.0	-	Ramp XSlope (%)	5.1
				N/A	Flare Type LT	N/A		Flare Type RT	N/A
				N/A	Flare Slope LT (%)		N/A	Flare Slope RT (%)	N/A
				N/A	Flare Traversable LT?		N/A	Flare Traversable RT?	N/A
13	188 11 1			N/A	Landing Length (in)		N/A	DWS Provided?	N/A
3ª @ @ / .				N/A	Landing Width (in)	N/A		DWS Contrast?	N/A
				N/A	Landing Slope (%)		N/A	DWS Length (in)	N/A
		N/A		N/A	Landing X Slope (%)	N/A		DWS Full Width?	N/A
<u>b.</u>	the state			N/A	Landing Curb? (Y/N)		N/A	DWS Offset (in)	N/A N/A

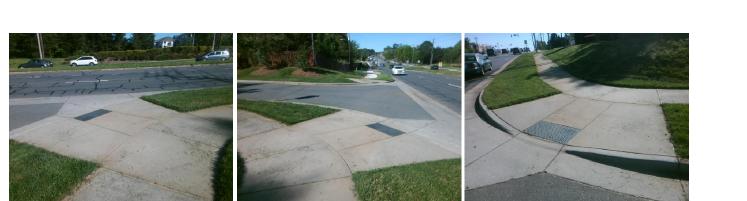
N/A	Shared Landing?	N/A	N/A	DWS Offset (III)	N/A
		PROW/ADA:		N/A	Gutter Ponding?		N/A	Gutter Slope (%)	N/A
A Parto	The start				•			,	
1 All and the		R304.5.1, R304.2.2, R304.5.3		N/A	Gutter Lip Ht (in)		N/A	Gutter X Slope (%)	N/A
	NOT THE O			N/A	Painted X Walk1?	No	N/A	Painted X Walk2?	No
		2			X Walk 1 Direction	To NW		X Walk 2 Direction	To SW
	8		N/A	X Walk 1 Width (in)	N/A	N/A	X Walk 2 Width (in)	N/A	
Street 1 Name	S TRYON ST				X Walk 1 Slope (%)	0.6		X Walk 2 Slope (%)	3.9
Stop Condition-Street 2	None				X Walk 1 X Slope (%)	3.1		X Walk 2 X Slope (%)	0.8
Street 2 Name	ENTRANCE			N/A	Ramp inside XWalk1?	N/A	N/A	Ramp inside XWalk2?	N/A
Stop Condition-Street 1	StopSign				Road Slope (%)	2.7	N/A	Clear Space?	N/A
					Road X Slope (%)	2.0	N/A	Clear Space to XWalk (in)	N/A
				N/A	Any Obstructions?	N/A	N/A	Storm Grate/Utility Hazard?	N/A
		Total Cost: \$	3200.00		Obstruction Type			Storm Grate/Utility Type
